Quality Assurance and Source Inspection

Contract #: 04-0120F4Cty: SF/ALA Rte: 80 PM: 13.2/13.9File #: 1.28**WELDING INSPECTION REPORT****Resident Engineer:** Pursell, Gary**Address:** 333 Burma Road**City:** Oakland, CA 94607**Report No:** WIR-012249**Date Inspected:** 23-Feb-2010**Project Name:** SAS Superstructure**OSM Arrival Time:** 700**Prime Contractor:** American Bridge/Fluor Enterprises, a JV**OSM Departure Time:** 1530**Contractor:** American Bridge/Fluor Enterprises, a JV**Location:** Job Site**CWI Name:** Mike Johnson, Jesse Cayabayab**CWI Present:** Yes No**Inspected CWI report:** Yes No N/A**Rod Oven in Use:** Yes No N/A**Electrode to specification:** Yes No N/A**Weld Procedures Followed:** Yes No N/A**Qualified Welders:** Yes No N/A**Verified Joint Fit-up:** Yes No N/A**Approved Drawings:** Yes No N/A**Approved WPS:** Yes No N/A**Delayed / Cancelled:** Yes No N/A**Bridge No:** 34-0006**Component:** SAS OBG 1E/2E**Summary of Items Observed:**

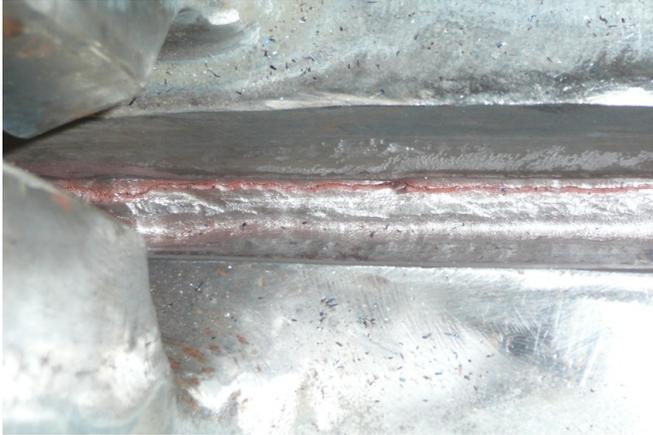
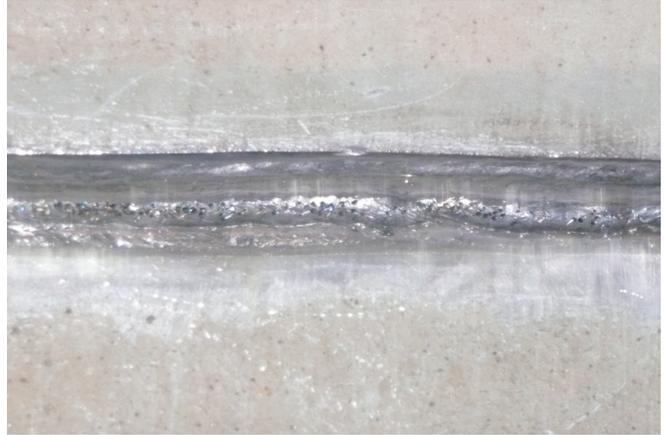
Upon the arrival of the QA Inspector it was observed the Smith Emery (SE) Quality Control (QC) Inspector Jesse Cayabayab had located a linear indication determined to be a crack in the weld pass previously deposited. The QA Inspector randomly observed the crack to be in the weld build up or joint restoration flux cored arc welding (FCAW) pass. It was noted the above identified weld joint had been buttered or restored on both sides of the joint from D1 thru D17. The QA Inspector randomly observed and noted the FCAW passes were joining the steel backing on both sides of the joint, tying or joining the two members together. The QA Inspector randomly observed the crack (pictured below) in the FCAW pass to extend from section D1 thru D7, approximately 2820mm in length.

buttering process between sections D1-D17. During a random visual inspection, the QA Inspector observed a crack in the section identified as D17. The QA Inspector noted the crack appeared to be as the same type of indications as the crack identified between D1-D7. The QA Inspector informed the QC Inspector Mike Johnson of the cracked area of weld.

require a critical weld repair to repair it. Mr. Bowers informed the QA Inspector he would submit a repair procedure for approval, in addition no repair would be made on the crack area until prior engineering approval is granted by Caltrans.
