**DEPARTMENT OF TRANSPORTATION**

Contract #: 04-0120F4Cty: SF/ALA Rte: 80 PM: 13.2/13.9File #: 1.28**WELDING INSPECTION REPORT****Resident Engineer:** Pursell, Gary**Address:** 333 Burma Road**City:** Oakland, CA 94607**Report No:** WIR-012370**Date Inspected:** 18-Feb-2010**Project Name:** SAS Superstructure**OSM Arrival Time:** 700**Prime Contractor:** American Bridge/Fluor Enterprises, a JV**OSM Departure Time:** 1530**Contractor:** American Bridge/Fluor Enterprises, a JV**Location:** Job Site**CWI Name:** Bernard Docena**CWI Present:** Yes No**Inspected CWI report:** Yes No N/A**Rod Oven in Use:** Yes No N/A**Electrode to specification:** Yes No N/A**Weld Procedures Followed:** Yes No N/A**Qualified Welders:** Yes No N/A**Verified Joint Fit-up:** Yes No N/A**Approved Drawings:** Yes No N/A**Approved WPS:** Yes No N/A**Delayed / Cancelled:** Yes No N/A**Bridge No:** 34-0006**Component:** Orthotropic Box Girders (OBG)**Summary of Items Observed:**

# WELDING INSPECTION REPORT

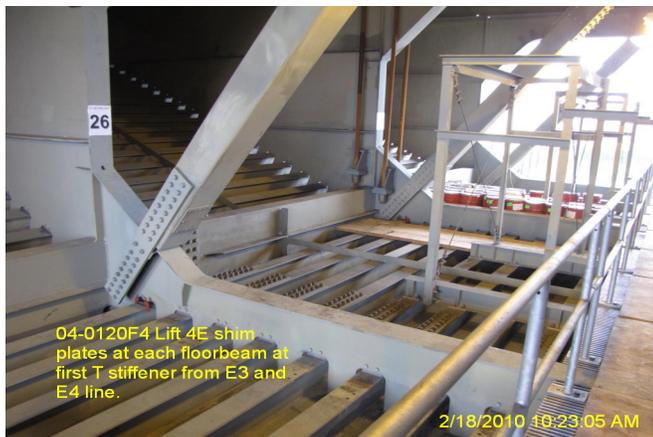
The QA inspector periodically observed ABF personnel performing the removal of the stiffener plate from the top of the "T" stiffeners utilizing a grinder, placing shims under the floor beams and placing an angle plate clamped to the top of the "T" stiffeners at each PP (24-28) along lines E3 and E4. These shim plates are being added in order to stiffen the area for jacking purposes in the field discussed per Submittal 1459. See digital photo included in the body of this report for clarification. The QA inspector reviewed several areas in which the welds were removed by

the contractor and noted the contractor is grinding the remaining weld metal flush with the top of the “T” stiffener in a workman like manor. The work progressed throughout the shift, was completed on this date and appeared to be in general conformance with the contract documents.

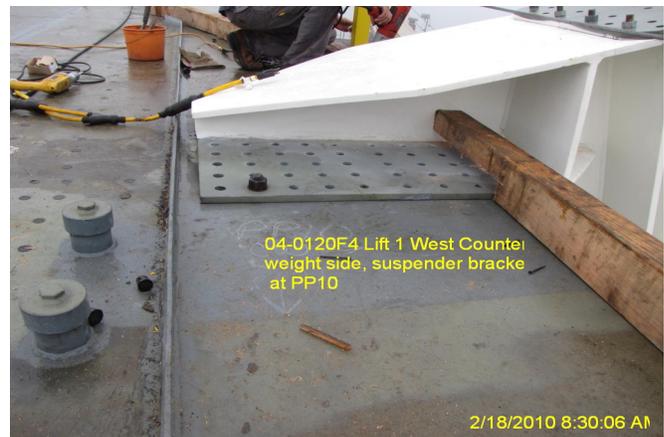
The QA inspector noted and periodically observed ABF personnel placing the suspender bracket at PP 10 for the North side (counter weight side) of the OBG. ABF personnel were utilizing various erection aids in order to place and align the bracket and inserted shims at the side plate. The QA inspector reviewed the fit-up between the deck plate and bracket faying surfaces and noted a 1mm gap at this time. A digital photo is included in the body of this report for clarification.
