**DEPARTMENT OF TRANSPORTATION**

Contract #: 04-0120F4Cty: SF/ALA Rte: 80 PM: 13.2/13.9File #: 1.28**WELDING INSPECTION REPORT****Resident Engineer:** Pursell, Gary**Address:** 333 Burma Road**City:** Oakland, CA 94607**Report No:** WIR-012373**Date Inspected:** 26-Feb-2010**Project Name:** SAS Superstructure**OSM Arrival Time:** 630**Prime Contractor:** American Bridge/Fluor Enterprises, a JV**OSM Departure Time:** 1500**Contractor:** American Bridge/Fluor Enterprises, a JV**Location:** Job Site

**1E/2E-A**

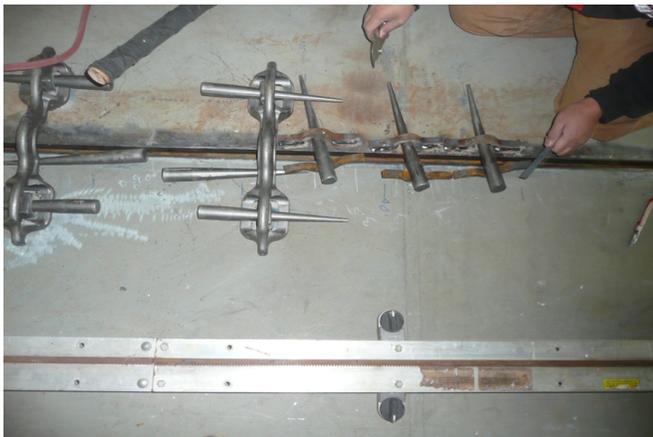
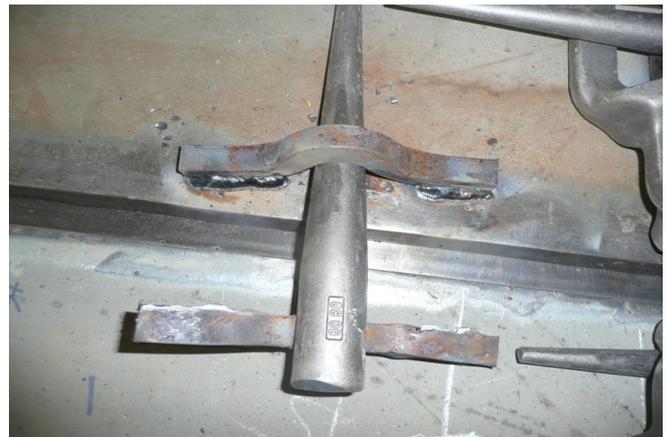
the ABF welder Al McDaniel preheat and perform shielded metal arc welding (SMAW) of a fitting aid. The QA Inspector observed Mr. Mc Daniel weld and attach the fitting aid to the top deck plate in the transverse direction of the longitudinal axis of the bridge (pictured below). The QA Inspector observed after the temporary attachment was installed, Mr. Clayborn drove the pin or wedge through the fitting aid to adjust the off set of the two members. The QA Inspector randomly observed the same process was repeated through the full length of the above identified weld joint. During the process of installing the temporary fitting aids, the QA Inspector informed the QC Inspector Mike Johnson and Jesse Cayabayab, as per ABF submittal identified as ABF-SUB-001361 R.2 temporary attachments could not be welded in the transverse direction of the longitudinal axis of the bridge. The QC Inspector Mike Johnson informed the QA Inspector he was unaware of the ABF submittal identified above and was not familiar of such a requirement. Mr. Johnson informed the QA Inspector he would need to consult with the ABF Welding Quality Control Manager (WQCM) Jim Bowers on the issue. The WQCM Jim Bowers later informed the QA Inspector, it is not feasible to utilize the fitting aids in any other fashion and it was necessary to weld them in the manner they have been utilizing them. Mr. Bowers went on to inform the QA Inspector it was unclear as to what exactly was transverse to the longitudinal axis of the bridge and he did not believe it was a complete violation of the above identified submittal. Mr. Bowers went on to inform the QA Inspector that the square nuts utilized in the fit up gear were not to be wrapped when welded as per the above identified submittal. The WQCM went on to inform the QA Inspector the manufacturer of the fit up gear, recommends wrapping the welds of the square nuts do to the applied force to them. The WQCM acknowledged wrapping the welds around the ends of the square nuts is possibly welding in the transverse direction but welding on only two sides could possibly cause additional damage to the base material if a square nut were to rip off during the applied force. The QA Inspector informed Mr. Bowers an Incident Report would be written and submitted for not conforming to the provisions of ABF-SUB-001361 R.2.

The QA Inspector randomly observed the ABF welder Al McDaniel and Mitch Sittinger preparing to continue to perform the FCAW tack weld started on the previous day shift. The QA Inspector observed the induction heat blankets had achieved the minimum required preheat of 150°F for the given thickness of the top deck plate. The QA Inspector observed the ABF welder to be welding the FCAW tack weld utilizing the given parameters of ABF-WPS-D1.5-F3200-2. The QA Inspector randomly verified the FCAW parameters and they were 242 Amps, 22.7 Volts and a travel speed of 425mm/min. The QA Inspector observed the ABF welder Mitch Sittinger weld the FCAW tack weld on one side of the joint approximately 9 feet long. The QA Inspector noted the welding was stopped due to unpredictable weather.
