**DEPARTMENT OF TRANSPORTATION**

Contract #: 04-0120F4Cty: SF/ALA Rte: 80 PM: 13.2/13.9File #: 1.28**WELDING INSPECTION REPORT****Resident Engineer:** Pursell, Gary**Address:** 333 Burma Road**City:** Oakland, CA 94607**Report No:** WIR-012375**Date Inspected:** 03-Mar-2010**Project Name:** SAS Superstructure**OSM Arrival Time:** 700**Prime Contractor:** American Bridge/Fluor Enterprises, a JV**OSM Departure Time:** 1500**Contractor:** American Bridge/Fluor Enterprises, a JV**Location:** Job Site**CWI Name:** Bill Norris/Steve McConnell**CWI Present:** Yes No**Inspected CWI report:** Yes No N/A**Rod Oven in Use:** Yes No N/A**Electrode to specification:** Yes No N/A**Weld Procedures Followed:** Yes No N/A**Qualified Welders:** Yes No N/A**Verified Joint Fit-up:** Yes No N/A**Approved Drawings:** Yes No N/A**Approved WPS:** Yes No N/A**Delayed / Cancelled:** Yes No N/A**Bridge No:** 34-0006**Component:** Orthotropic Box Girders (OBG)**Summary of Items Observed:**

# WELDING INSPECTION REPORT

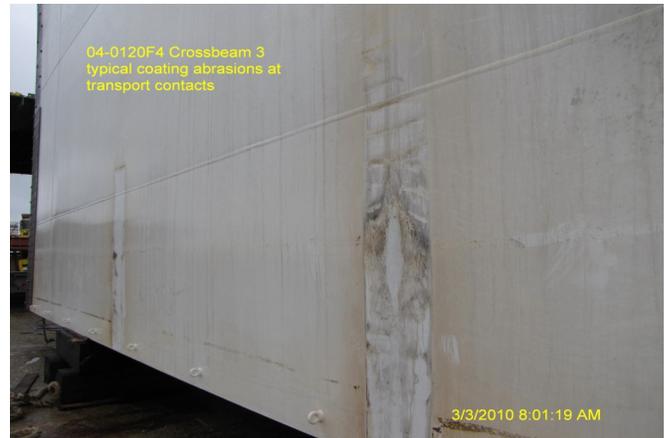
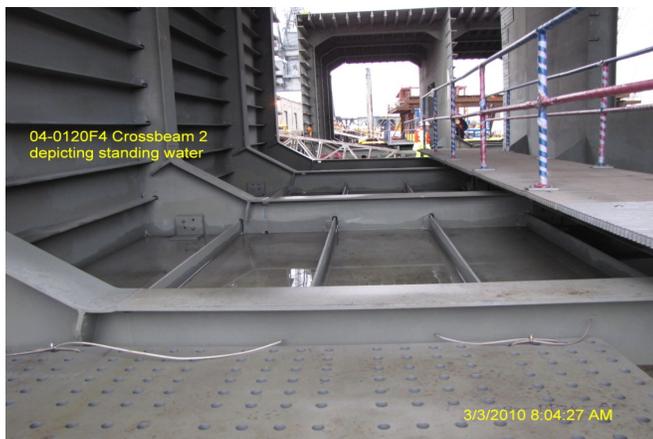
1. Standing water was observed inside the crossbeam
2. A pad eye attached near the bottom of the crossbeam near Panel Point (PP) 22 had apparently been bent during shipping/handling.

Digital photos are included in the body of this report for clarification. This information was relayed to the SMR and the Structure Construction personnel present. This completes the review of this component on this date.
