DEPARTMENT OF TRANSPORTATION

Contract #: 04-0120F4Cty: SF/ALA Rte: 80 PM: 13.2/13.9File #: 1.28**WELDING INSPECTION REPORT****Resident Engineer:** Pursell, Gary**Address:** 333 Burma Road**City:** Oakland, CA 94607**Report No:** WIR-012376**Date Inspected:** 01-Mar-2010**Project Name:** SAS Superstructure**OSM Arrival Time:** 630**Prime Contractor:** American Bridge/Fluor Enterprises, a JV**OSM Departure Time:** 1500**Contractor:** American Bridge/Fluor Enterprises, a JV**Location:** Job Site

WELDING INSPECTION REPORT

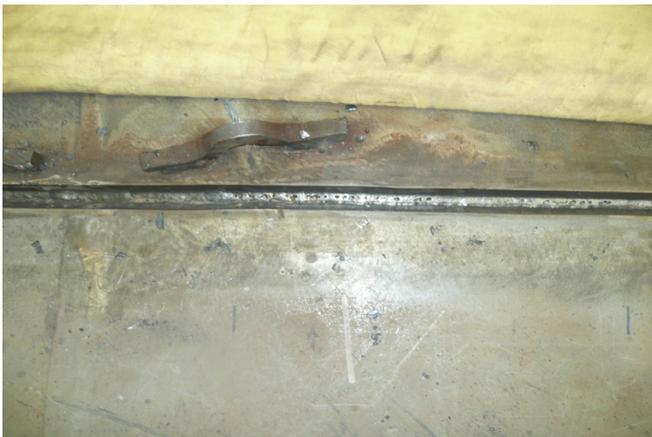
identified weld joint was joined by welding when both sides of the joint were welded to the steel backing bar. The QA Inspector randomly observed the ABF welder experience approximately 200mm of porosity in section A2 (pictured below). The QA Inspector noted the porosity was not removed on the QA Inspectors shift. The QA Inspector informed the QC Inspector Jim Cunningham of the porosity. Mr. Cunningham informed the QA Inspector he would instruct the ABF welder to remove the porosity and magnetic particle testing would be performed to ensure the entire weld defect was removed.
