Contract #: 04-0120F4Cty: SF/ALA Rte: 80 PM: 13.2/13.9File #: 69.28**WELDING INSPECTION REPORT****Resident Engineer:** Pursell, Gary**Address:** 333 Burma Road**City:** Oakland, CA 94607**Report No:** WIR-012400**Date Inspected:** 20-Feb-2010**Project Name:** SAS Superstructure**OSM Arrival Time:** 1900**Prime Contractor:** American Bridge/Fluor Enterprises, a JV**OSM Departure Time:** 700**Contractor:** Zhenhua Port Machinery Company, Ltd (ZPMC), Changxing Island **Location:** Shanghai, China

WELDING INSPECTION REPORT

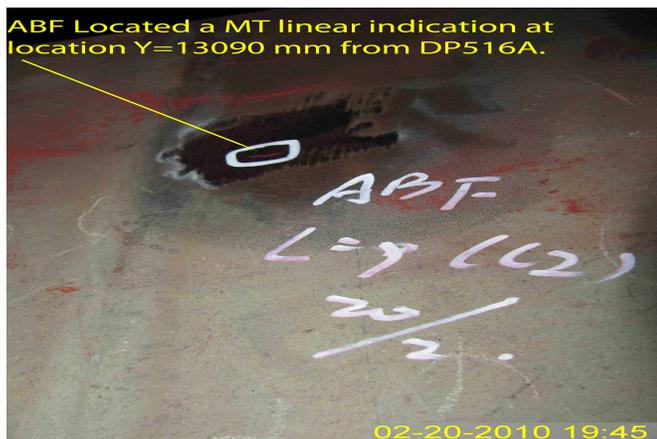
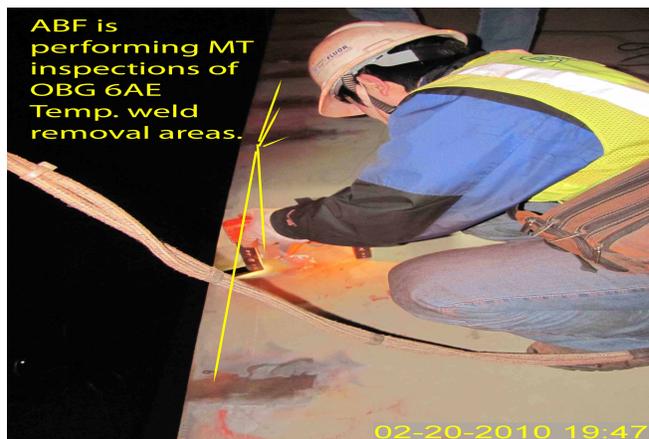
This QA Inspector observed ABF personnel performing magnetic particle inspections of temporary alignment weld removal areas on the edge of OBG segment 6AE adjacent to where OBG segment 5CE will be welded at a later time. ABF personnel identified two magnetic particle rejections, one with a length of 9mm at location Y=8730mm and one with a length of 8mm at location Y=13090mm. See the photographs below for additional information.

This QA Inspector and Caltrans QA Inspector Mr. Mike Hasler performed magnetic particle inspections of temporary alignment weld removal areas on the edge of OBG segment 6AE, near panel point 37 where ABF personnel had previously performed magnetic particle inspections. The following top deck plates were inspected: DP516A, DP300A, DP327A, DP354A, DP381A, DP408A, DP435A, DP462A, DP327A, DP489A and CA26A. The areas that were inspected appear to comply with project specifications, except for the two locations where ABF had previously identified linear indications in the base material. These temporary welds had been installed to align the top deck plates of OBG segment 6AE with OBG segment 5CE. These magnetic particle inspections were performed as an informational basis and no TL6028 Magnetic Particle Test Report was issued. See the photograph below for additional information.
