**DEPARTMENT OF TRANSPORTATION**

Contract #: 04-0120F4Cty: SF/ALA Rte: 80 PM: 13.2/13.9File #: 69.28**WELDING INSPECTION REPORT****Resident Engineer:** Pursell, Gary**Address:** 333 Burma Road**City:** Oakland, CA 94607**Report No:** WIR-012406**Date Inspected:** 26-Feb-2010**Project Name:** SAS Superstructure**OSM Arrival Time:** 1900**Prime Contractor:** American Bridge/Fluor Enterprises, a JV**OSM Departure Time:** 700**Contractor:** Zhenhua Port Machinery Company, Ltd (ZPMC), Changxing Island **Location:** Shanghai, China**CWI Name:** See Below**CWI Present:** Yes No**Inspected CWI report:** Yes No N/A**Rod Oven in Use:** Yes No N/A**Electrode to specification:** Yes No N/A**Weld Procedures Followed:** Yes No N/A**Qualified Welders:** Yes No N/A**Verified Joint Fit-up:** Yes No N/A**Approved Drawings:** Yes No N/A**Approved WPS:** Yes No N/A**Delayed / Cancelled:** Yes No N/A**Bridge No:** 34-0006**Component:** OBG & Tower**Summary of Items Observed:**

## WELDING INSPECTION REPORT

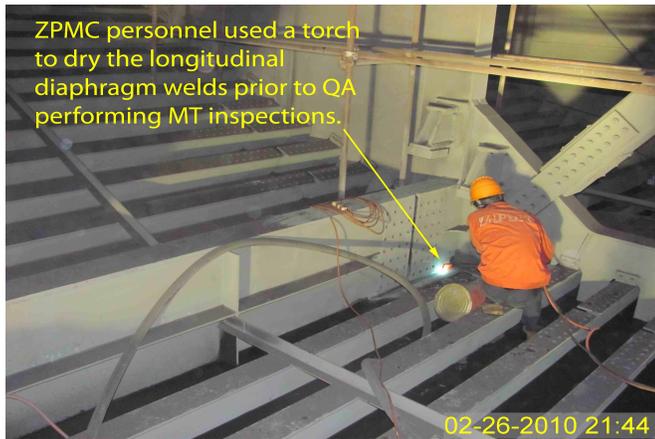
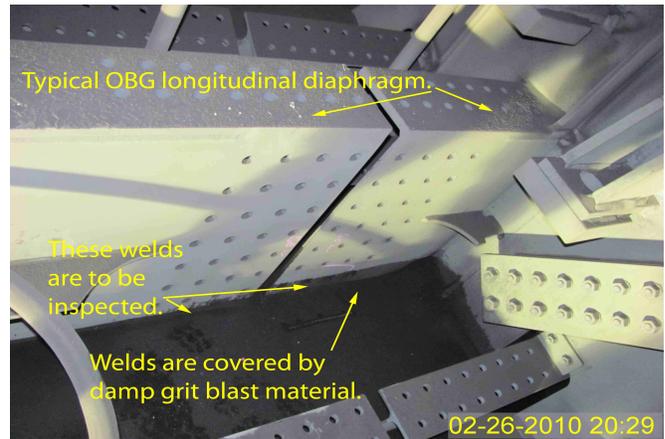
ZPMC had previously informed dayshift Caltrans personnel that various longitudinal diaphragm hold back welds on OBG segments 5AW/5BW/5CW are ready for QA magnetic particle inspections. Dayshift Caltrans QA personnel informed this QA Inspector that ZPMC has personnel assigned to remove blasting grit and use a torch to remove rain water from longitudinal diaphragm hold back welds on the OBG segments. This QA Inspector and Caltrans QA Inspector Mr. Mike Hasler visually observed the longitudinal diaphragm welds that were listed on the ZPMC green tag #3 tracking sheets have not been cleaned and several of them are wet due to rain water accumulations. This QA Inspector attempted to communicate with the ZPMC foreman to request that ZPMC personnel clean and dry the longitudinal diaphragm hold back welds prior to QA performing magnetic particle inspections. ZPMC workers initially used a broom and rags to clean the weld surfaces. The rags were not effective on removing the moisture from the welds as required by the magnetic particle inspection procedure. Caltrans QA Inspector Mr. Mike Hasler used his cell phone to call ZPMC representative Mr. Lay Tao who came to OBG segments 5AW/5BW/5CW. Mr. Lay Tao informed the ZPMC supervisor of the need to use a torch to remove the water/moisture from the weld surfaces. Following cleaning and drying of the weld surfaces, this QA Inspector performed magnetic particle inspections of longitudinal diaphragm hold back welds at the splice joint between OBG segments 5AW/PP32 and 5BW/PP33 weld numbers: Seg023B-007, Seg023B-008, Seg023C-007, Seg023C-008, Seg021B-029, Seg021B-030, Seg021C-029 and Seg021C-030. The areas that were inspected appear to comply with project specifications and this QA Inspector issued a TL6028 Magnetic Particle Test Report

to document these inspections. See the photographs below for additional information.
