DEPARTMENT OF TRANSPORTATION

Contract #: 04-0120F4Cty: SF/ALA Rte: 80 PM: 13.2/13.9File #: 1.28**WELDING INSPECTION REPORT****Resident Engineer:** Pursell, Gary**Address:** 333 Burma Road**City:** Oakland, CA 94607**Report No:** WIR-012448**Date Inspected:** 04-Mar-2010**Project Name:** SAS Superstructure**OSM Arrival Time:** 630**Prime Contractor:** American Bridge/Fluor Enterprises, a JV**OSM Departure Time:** 1500**Contractor:** American Bridge/Fluor Enterprises, a JV**Location:** Job Site

CWI Name:	Mike Johnson, Jesse Cayabayab, JCWI, Prashant	CWI Present:	Yes	No			
Inspected CWI report:	Yes	No	N/A	Rod Oven in Use:	Yes	No	N/A
Electrode to specification:	Yes	No	N/A	Weld Procedures Followed:	Yes	No	N/A
Qualified Welders:	Yes	No	N/A	Verified Joint Fit-up:	Yes	No	N/A
Approved Drawings:	Yes	No	N/A	Approved WPS:	Yes	No	N/A
				Delayed / Cancelled:	Yes	No	N/A
Bridge No:	34-0006	Component:	SAS OBG 1E/2E-A

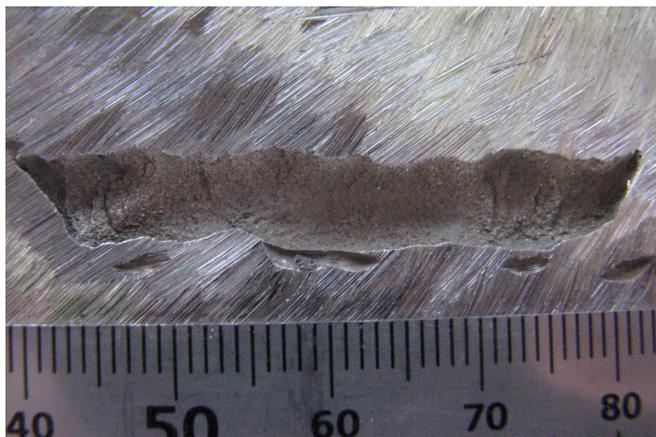
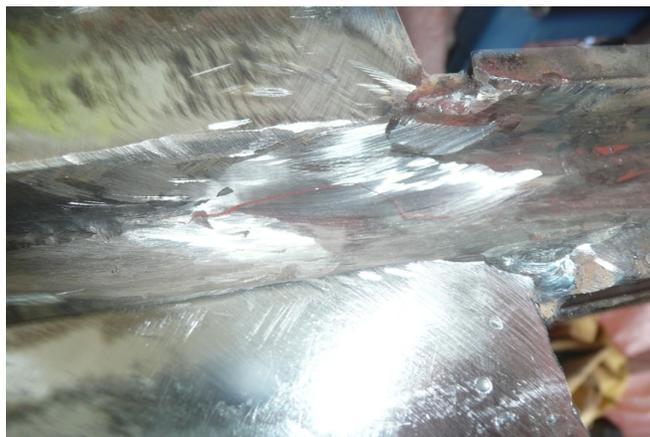
1E/2E-D

The WQCM informed the QA Inspector previously of under cut where the fit up gear or fitting aids were removed at the above identified location. Upon the arrival of the QA Inspector, It was observed significant base material damage had occurred during the removal of the temporary attachments (pictured below). The QA Inspector randomly observed when the temporary attachment was removed it appeared the base material was torn or fractured. The QA Inspector observed three locations, approximately the same size (23mmX5mmX2mm) where the damage had occurred (see summary of conversations). The QA Inspector noted an Incident Report was written

and submitted for the non conformance of section 3.3.7.3 of AWS D1.5-02 “Tack welds not incorporated into the final weld shall be removed in such a manner that the base metal is not nicked or undercut.”

The QA Inspector was informed by the QC Inspector Mike Johnson, the welds just fell off the bottom of the “D” plate after the fit up gear was removed. Mr. Johnson went on to inform the QA Inspector, when the weld fell off a chunk of base material fell with it. The WQCM informed the QA Inspector, he was informed by the ABF welders the base material was damaged due to the applied force of the pins in the fit up gear along with cycling of the heat above the fit up gear. The QA Inspector informed the WQCM, at a separate location an ABF welder was observed utilizing a sledge hammer and force to remove the temporary attachments. The QA Inspector went on to inform the WQCM that method was not observed at the above location but it was previously observed
