Contract #: 04-0120F4Cty: SF/ALA Rte: 80 PM: 13.2/13.9File #: 1.28**WELDING INSPECTION REPORT****Resident Engineer:** Pursell, Gary**Address:** 333 Burma Road**City:** Oakland, CA 94607**Report No:** WIR-012460**Date Inspected:** 01-Mar-2010**Project Name:** SAS Superstructure**OSM Arrival Time:** 700**Prime Contractor:** American Bridge/Fluor Enterprises, a JV**OSM Departure Time:** 1530**Contractor:** American Bridge/Fluor Enterprises, a JV**Location:** Job Site**CWI Name:** Bonafacio Daquinag**CWI Present:** Yes No**Inspected CWI report:** Yes No N/A**Rod Oven in Use:** Yes No N/A**Electrode to specification:** Yes No N/A**Weld Procedures Followed:** Yes No N/A**Qualified Welders:** Yes No N/A**Verified Joint Fit-up:** Yes No N/A**Approved Drawings:** Yes No N/A**Approved WPS:** Yes No N/A**Delayed / Cancelled:** Yes No N/A**Bridge No:** 34-0006**Component:** Orthotropic Box Girders (OBG)**Summary of Items Observed:**

**Lift 2 West**

# WELDING INSPECTION REPORT

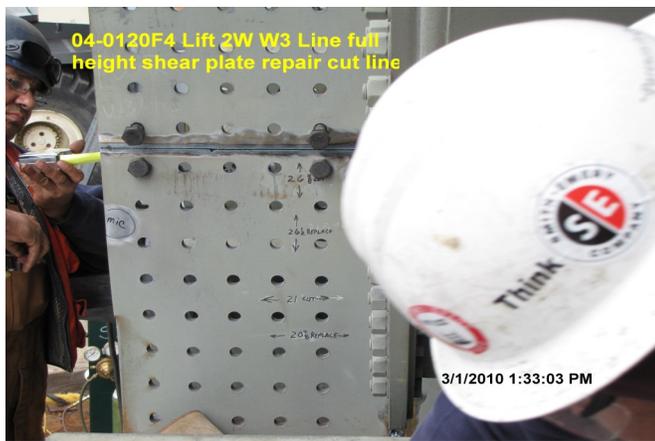
The QA inspector was informed by the Welding Quality Control Manager (WQCM) Jim Bowers the contractor is scheduled to perform the removal of the damaged area on the full height vertical shear plate at the W3 line of Lift 2 West. The QA inspector periodically observed ABF welding personnel John Rosas (ID-1480) and a helper lay-out the removal area dimensions which were approximately 650mm high and 530mm wide. This work is proceeding under repair submittal ABF-SUB-001503 R0 which has been previously approved by structure construction. The welder relayed he was unable to place automated equipment in the space allowed and informed the QA inspector he would be using a guide in order to perform the cutting operation of the vertical and top horizontal cut and air carbon arc gouging for the removal of the weld along the bottom plate. Prior to the removal operation the QC inspector Bonafacio Daquinag was observed performing magnetic particle testing of the existing weld joining the shear plate to the bottom plate with no rejectable indications noted at the time of review. The QA inspector observed the cutting operation and periodically observed the gouging operation which was performed in a workman like manner. It was noted QC inspector Bonafacio Daquinag was present in order to document and observe the in process work. Later in the shift the QA inspector reviewed the completed work at this location and

it appeared to be in general conformance with the contract documents. See digital photo included in the body of this report for general information or clarification.

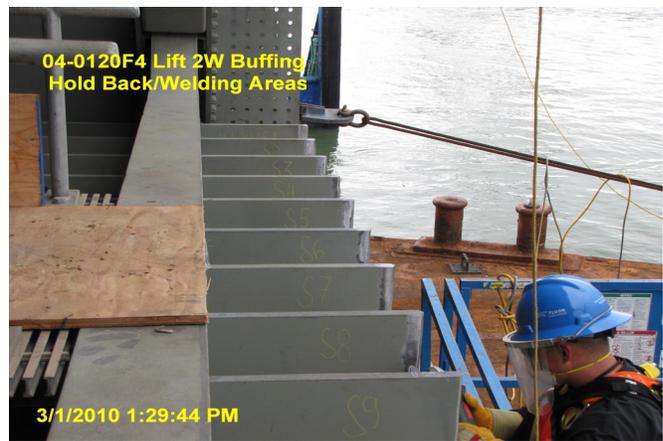
The QA inspector periodically observed ABF personnel performing grinding/buffing of the weld and hold back areas of the longitudinal stiffeners (open ribs) along the bottom and side plates of lift 2W at Panel Point 13 (PP13). This work progressed throughout the shift, was not completed and appeared to be progressing in general conformance with the contract documents. See digital photo in the body of this report for general review.
