DEPARTMENT OF TRANSPORTATION

Contract #: 04-0120F4Cty: SF/ALA Rte: 80 PM: 13.2/13.9File #: 1.28**WELDING INSPECTION REPORT****Resident Engineer:** Pursell, Gary**Address:** 333 Burma Road**City:** Oakland, CA 94607**Report No:** WIR-012484**Date Inspected:** 08-Mar-2010**Project Name:** SAS Superstructure**OSM Arrival Time:** 630**Prime Contractor:** American Bridge/Fluor Enterprises, a JV**OSM Departure Time:** 1500**Contractor:** American Bridge/Fluor Enterprises, a JV**Location:** Job Site

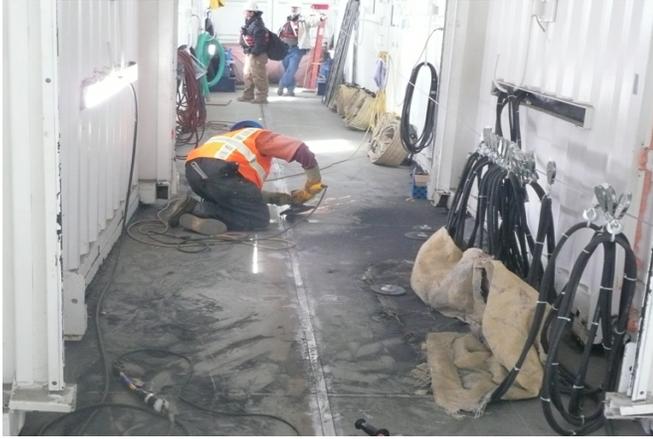
The QA Inspector noted the ABF welder Rick Clayborn was setting up to perform the complete joint penetration (CJP) weld splices of the steel backing. The QA Inspector randomly observed the ABF welding representatives identified above had cut and ground bevels in 5 total sections of the 1-1/2" steel backing. The QA Inspector noted the steel backing was being fit up in accordance with pre qualified weld joint designated Bu-2. The QA Inspector verified a 60° included angle single vee groove for a total of 4 CJP weld splices in the steel backing. The QA Inspector randomly observed and noted the SE QC Inspector Bnifacio Daquinag was on site performing visual testing (VT) of the fit up of steel backing prior to welding. After the fit up of the steel backing was accepted by the QC Inspector, the QA Inspector randomly observed the ABF welder Rick Clayborn performing shielded metal arc welding (SMAW) root, fill and cover passes in all 4 of the fit up grooves after preheating to 100°F with a rosebud torch.

The QA Inspector randomly observed the ABF welders to be utilizing a new box of Lincoln E7018 H4R low hydrogen electrodes. The QA Inspector randomly observed the SE QC Inspector Mike Johnson set the SMAW machine to 130Amps, which appeared to be in general compliance with ABF-WPS-D1.5-1031 Rev.0. The QA Inspector randomly observed the ABF welders install weld tabs to either side of the joints to perform the CJP groove welds. The QA Inspector randomly observed the ABF welders complete 4 of the 4 steel backing bar splices from the front side of the joint. The QA Inspector randomly observed the ABF welders back gouge the 4 splices with a grinding disc. After the CJP groove welds had been back gouged to bright metal, the SE QC Inspector Bnifacio Daquinag performed magnetic particle testing (MT). The QA Inspector randomly observed no relevant indications were located at the time of the testing. After the welding was completed the QA Inspector randomly observed the QC Steve McConnell Inspector perform UT 100% of the four CJP weld splices. The QA Inspector noted no rejectable indications were located at the time of the testing. The QA Inspector performed UT of 100% of two of the four CJP weld splices and noted no rejectable indications were located at the time of the testing.
