DEPARTMENT OF TRANSPORTATION

Quality Assurance and Source Inspection

Contract #: 04-0120F4Cty: SF/ALA Rte: 80 PM: 13.2/13.9File #: 69.28**WELDING INSPECTION REPORT****Resident Engineer:** Pursell, Gary**Address:** 333 Burma Road**City:** Oakland, CA 94607**Report No:** WIR-012505**Date Inspected:** 23-Feb-2010**Project Name:** SAS Superstructure**OSM Arrival Time:** 700**Prime Contractor:** American Bridge/Fluor Enterprises, a JV**OSM Departure Time:** 1900**Contractor:** Zhenhua Port Machinery Company, Ltd (ZPMC), Changxing Island **Location:** Shanghai, China**CWI Name:** Chen Xi.**CWI Present:** Yes No**Inspected CWI report:** Yes No N/A**Rod Oven in Use:** Yes No N/A**Electrode to specification:** Yes No N/A**Weld Procedures Followed:** Yes No N/A**Qualified Welders:** Yes No N/A**Verified Joint Fit-up:** Yes No N/A**Approved Drawings:** Yes No N/A**Approved WPS:** Yes No N/A**Delayed / Cancelled:** Yes No N/A**Bridge No:** 34-0006**Component:** OBG**Summary of Items Observed:**

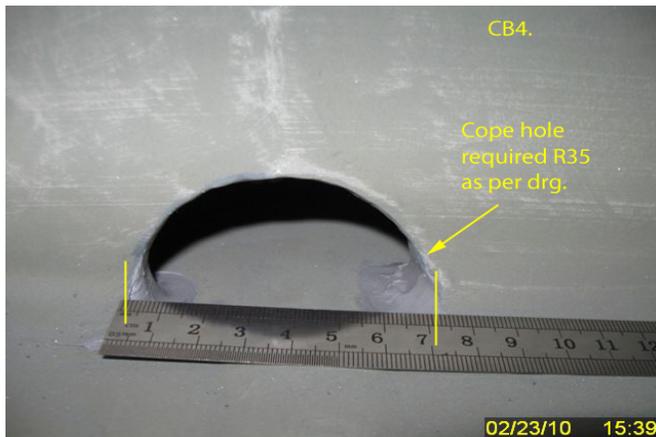
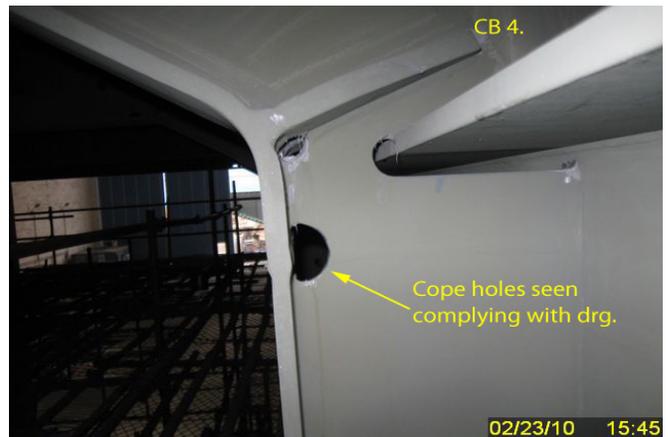
During random inprocess visual inspection, this QA Inspector inspected the cope holes of this Cross Beam. It was seen that these cope holes were found to be complying with the drawing requirements. Refer attached photos for further information. Final painting is completed for this cross beam.

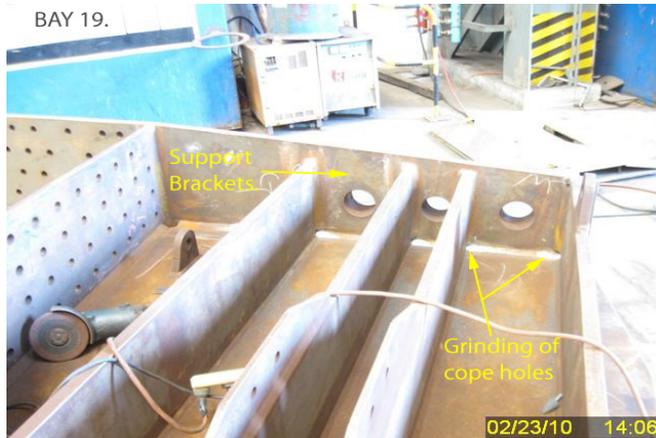
During random inprocess visual inspection, this QA Inspector observed ZPMC personnel performing grinding of cope holes of Support Brackets. This QA Inspector did random inprocess visual inspection for cope holes of SB36W, SB40W & SB44W and were found to be complying with the drawing requirements. ZPMC QC was identified as Cheng Zhou. Refer attached photos for further information.
