DEPARTMENT OF TRANSPORTATION

Contract #: 04-0120F4Cty: SF/ALA Rte: 80 PM: 13.2/13.9File #: 69.28**WELDING INSPECTION REPORT****Resident Engineer:** Pursell, Gary**Address:** 333 Burma Road**City:** Oakland, CA 94607**Report No:** WIR-012506**Date Inspected:** 22-Feb-2010**Project Name:** SAS Superstructure**OSM Arrival Time:** 700**Prime Contractor:** American Bridge/Fluor Enterprises, a JV**OSM Departure Time:** 1900**Contractor:** Zhenhua Port Machinery Company, Ltd (ZPMC), Changxing Island **Location:** Shanghai, China**CWI Name:** Chen Xi.**CWI Present:** Yes No**Inspected CWI report:** Yes No N/A**Rod Oven in Use:** Yes No N/A**Electrode to specification:** Yes No N/A**Weld Procedures Followed:** Yes No N/A**Qualified Welders:** Yes No N/A**Verified Joint Fit-up:** Yes No N/A**Approved Drawings:** Yes No N/A**Approved WPS:** Yes No N/A**Delayed / Cancelled:** Yes No N/A**Bridge No:** 34-0006**Component:** OBG**Summary of Items Observed:**

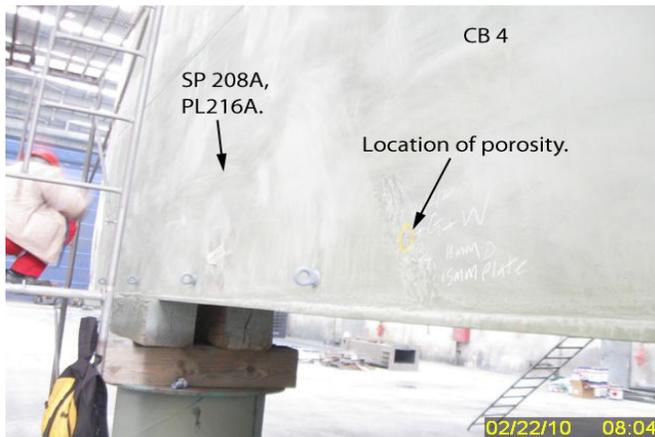
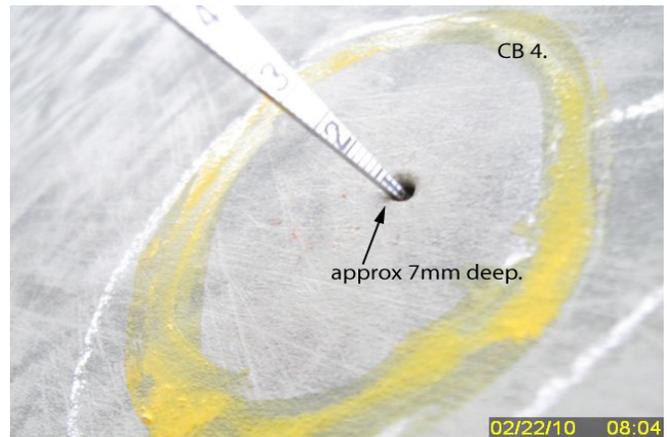
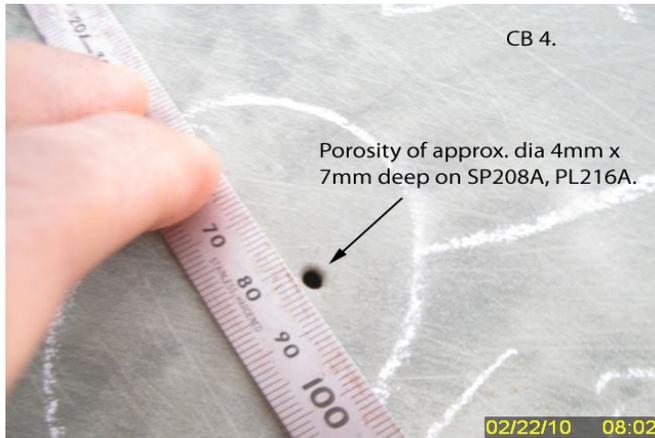
- One porosity (of Ø approx 4mm x 7mm deep) on Side Panel – SP 208A (16mm plate thickness).
- This needs to be weld repaired. Material is identified as Seismic Performance Critical Member (SPCM).
- This QA Inspector discussed this issue with ZPMC CWI Mr. Xu Xian Ping and it was understood that ZPMC had already submitted a Critical Weld Repair Report (CWR), No: CWR 1220 Dt: 02/21.10, for approval.

- Primer application is already completed on this CB.
