**DEPARTMENT OF TRANSPORTATION**

Contract #: 04-0120F4Cty: SF/ALA Rte: 80 PM: 13.2/13.9File #: 69.28**WELDING INSPECTION REPORT****Resident Engineer:** Pursell, Gary**Address:** 333 Burma Road**City:** Oakland, CA 94607**Report No:** WIR-012519**Date Inspected:** 14-Feb-2010**Project Name:** SAS Superstructure**OSM Arrival Time:** 700**Prime Contractor:** American Bridge/Fluor Enterprises, a JV**OSM Departure Time:** 1900**Contractor:** Zhenhua Port Machinery Company, Ltd (ZPMC), Changxing Island **Location:** Shanghai, China**CWI Name:** Mr. Gong liang zhu**CWI Present:** Yes No**Inspected CWI report:** Yes No N/A**Rod Oven in Use:** Yes No N/A**Electrode to specification:** Yes No N/A**Weld Procedures Followed:** Yes No N/A**Qualified Welders:** Yes No N/A**Verified Joint Fit-up:** Yes No N/A**Approved Drawings:** Yes No N/A**Approved WPS:** Yes No N/A**Delayed / Cancelled:** Yes No N/A**Bridge No:** 34-0006**Component:** Tower**Summary of Items Observed:**

# WELDING INSPECTION REPORT

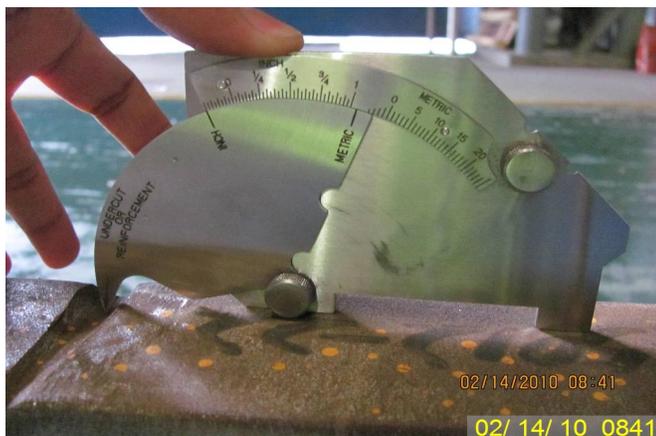
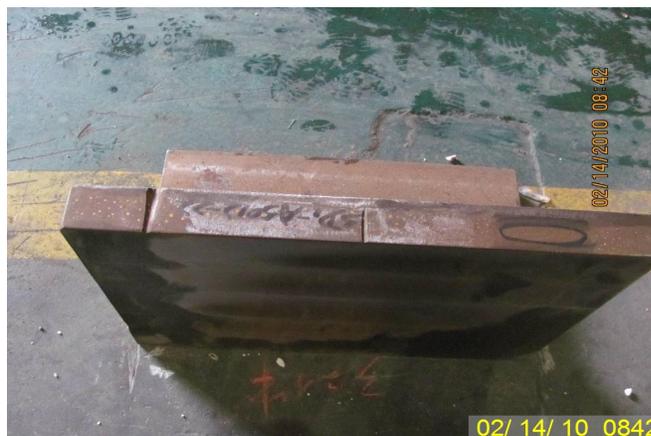
This QA inspector, Baskar Govindarajan, observed, Dent of approximately 6 mm in 60 thk. Parent metal of strut splice plate during random visual inspection. The identification of strut splice found to be SD1-A 5612-22. Photograph of depth measured with bridge cam is attached.
