**DEPARTMENT OF TRANSPORTATION**

Contract #: 04-0120F4Cty: SF/ALA Rte: 80 PM: 13.2/13.9File #: 69.28**WELDING INSPECTION REPORT****Resident Engineer:** Pursell, Gary**Address:** 333 Burma Road**City:** Oakland, CA 94607**Report No:** WIR-012582**Date Inspected:** 08-Mar-2010**Project Name:** SAS Superstructure**OSM Arrival Time:** 700**Prime Contractor:** American Bridge/Fluor Enterprises, a JV**OSM Departure Time:** 1900**Contractor:** Zhenhua Port Machinery Company, Ltd (ZPMC), Changxing Island **Location:** Shanghai, China**CWI Name:** Li Yang, Wu Chi Cheng**CWI Present:** Yes No**Inspected CWI report:** Yes No N/A**Rod Oven in Use:** Yes No N/A**Electrode to specification:** Yes No N/A**Weld Procedures Followed:** Yes No N/A**Qualified Welders:** Yes No N/A**Verified Joint Fit-up:** Yes No N/A**Approved Drawings:** Yes No N/A**Approved WPS:** Yes No N/A**Delayed / Cancelled:** Yes No N/A**Bridge No:** 34-0006**Component:** Orthotropic Box Girder (OBG)**Summary of Items Observed:**

**OBG # TRIAL ASSEMBLY YARD**

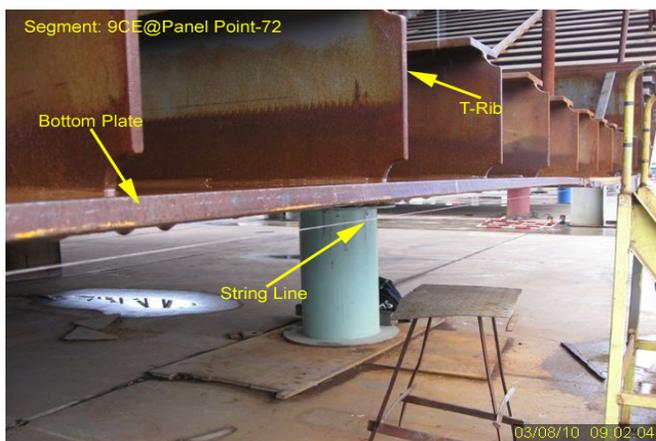
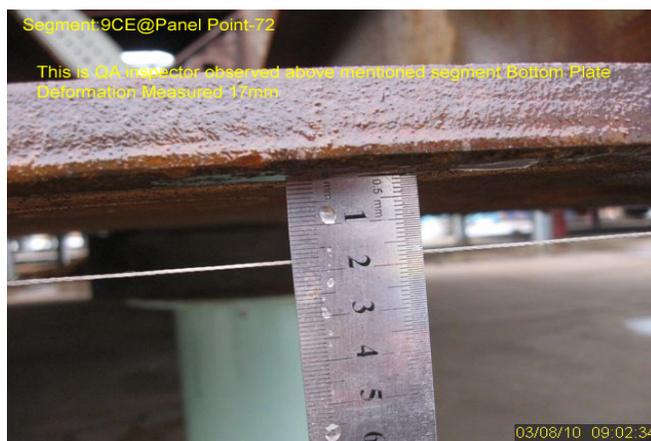
This QA Inspector along with Caltrans QA Mr. Surendra Prabhu performed Joint Inspection for the Bottom Plate Skin Flatness measured. See the attached below Photo.

This QA inspector observed, ZPMC qualified welding personnel identified as 048659 perform Shielded Metal Arc Welding (SMAW), weld joint identified as SSD10A-PP38-170; The Welding Repair Report (WRR) was B-WR10687. ZPMC QC is identified as Mr. Wan Li Yang. The welding parameters measured using QC's calibrated instrument appeared to be in general compliance with WPS-345-FCAW-4G (4F)-FCM-Repair-1.
