DEPARTMENT OF TRANSPORTATION

Contract #: 04-0120F4Cty: SF/ALA Rte: 80 PM: 13.2/13.9File #: 69.28**WELDING INSPECTION REPORT****Resident Engineer:** Pursell, Gary**Address:** 333 Burma Road**City:** Oakland, CA 94607**Report No:** WIR-012609**Date Inspected:** 20-Feb-2010**Project Name:** SAS Superstructure**OSM Arrival Time:** 700**Prime Contractor:** American Bridge/Fluor Enterprises, a JV**OSM Departure Time:** 1900**Contractor:** Zhenhua Port Machinery Company, Ltd (ZPMC), Changxing Island **Location:** Shanghai, China

WELDING INSPECTION REPORT

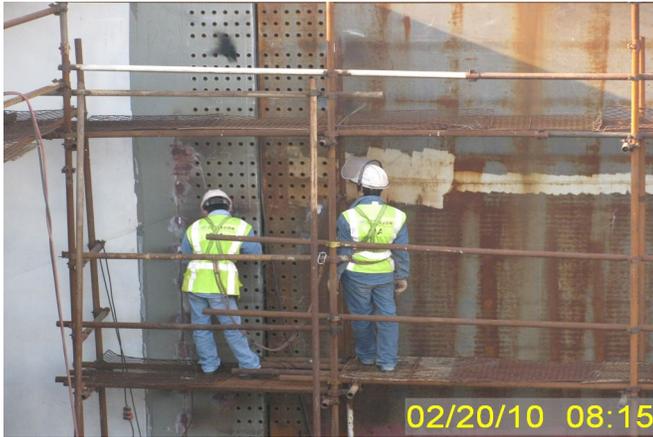
This inspector witnessed Magnetic Particle Inspections, MT, being performed by ABF on section 6AE at the cross beam splice on the East side. This inspection was performed on the temporary weld areas that had been previously ground flush. Indications were noted by ABF at the time of inspection. For more information on rejected indications, see the ABF MT reports for these sections and date.

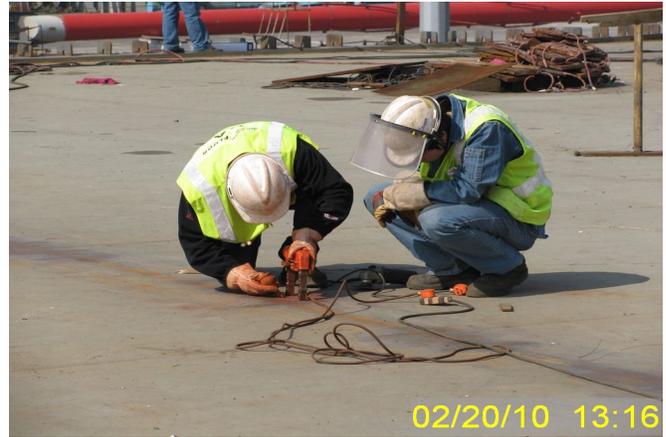
This inspector witnessed Magnetic Particle Inspections, MT, being performed by ABF on section 6AE at the corner joint, cross beam side, at the 6AE to 6BE transverse deck splice. This inspection was performed on the weld repaired areas that had been previously ground flush. Indications were noted by ABF at the time of inspection. For more information on rejected indications, see the ABF MT reports for these sections and date.

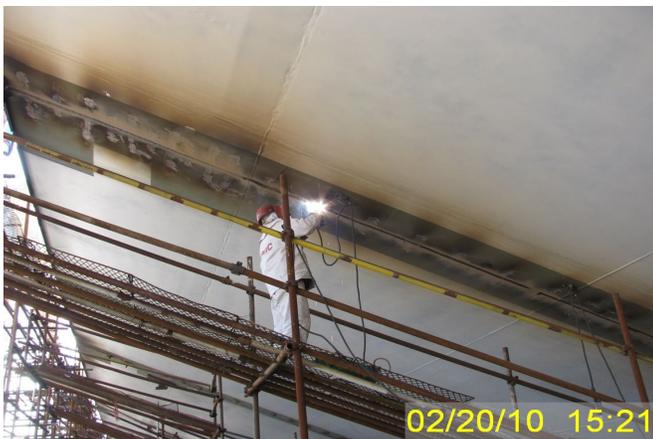
This inspector witnessed SMAW being performed on the 7AE to 7BE side plate transverse splice, bike path side. The 2 welders were identified as 037743 and 066038. ZPMC QC was identified as Mr. Shen Jian Bo. The welding procedure used for this operation was identified as WPS- B- P- 2214- B- U2.
