**DEPARTMENT OF TRANSPORTATION**

Contract #: 04-0120F4Cty: SF/ALA Rte: 80 PM: 13.2/13.9File #: 69.28**WELDING INSPECTION REPORT****Resident Engineer:** Pursell, Gary**Address:** 333 Burma Road**City:** Oakland, CA 94607**Report No:** WIR-012610**Date Inspected:** 19-Feb-2010**Project Name:** SAS Superstructure**OSM Arrival Time:** 700**Prime Contractor:** American Bridge/Fluor Enterprises, a JV**OSM Departure Time:** 1900**Contractor:** Zhenhua Port Machinery Company, Ltd (ZPMC), Changxing Island **Location:** Shanghai, China

# WELDING INSPECTION REPORT

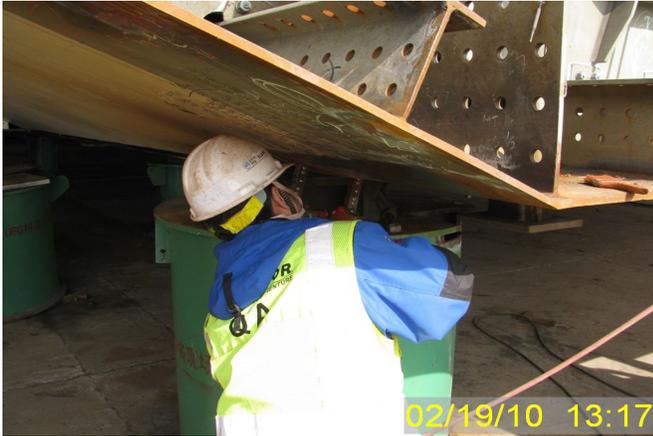
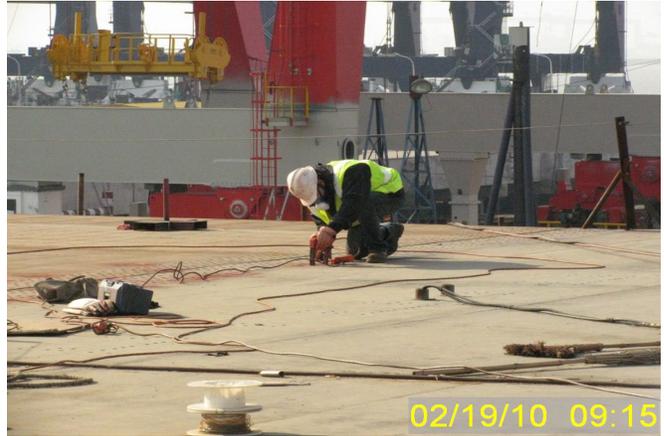
This inspector performed Conventional Ultrasonic Testing, (UT), on Weld ID Seg027- 044 and Seg027-048. These welds are identified as deck plate to edge plate welds on OBG sections 6AW and 6BW. This inspection was in conjunction with ABF UT technicians and was to verify rejected indications by ABF and was in accordance with the current "D" scan procedure. For more information on rejected indications, see the ABF UT reports for these sections and date.

This inspector witnessed Magnetic Particle Inspections, MT, being performed by ABF on section 6AW at the cross beam splice on the deck. This inspection was performed on the temporary weld areas that had been previously ground flush. Indications were noted by ABF at the time of inspection. For more information on rejected indications, see the ABF MT reports for these sections and date.

corner joint, cross beam side, at the 5CE/ 6AE splice area. This inspection was performed on the weld repaired areas that had been previously ground flush. Indications were noted by ABF at the time of inspection, and were lightly ground to remove. Area was considered to have no recordable indication after grinding.
