**DEPARTMENT OF TRANSPORTATION**

Contract #: 04-0120F4Cty: SF/Ala Rte: 80 PM: 13.2/13.9File #: 69.28**WELDING INSPECTION REPORT****Resident Engineer:** Pursell, Gary**Address:** 333 Burma Road**City:** Oakland, CA 94607**Report No:** WIR-012625**Date Inspected:** 26-Feb-2010**Project Name:** SAS Superstructure**OSM Arrival Time:** 1900**Prime Contractor:** American Bridge/Fluor Enterprises, a JV**OSM Departure Time:** 700**Contractor:** Zhenhua Port Machinery Company, Ltd (ZPMC), Changxing Island **Location:** Shanghai, China**CWI Name:** see below**CWI Present:** Yes No**Inspected CWI report:** Yes No N/A**Rod Oven in Use:** Yes No N/A**Electrode to specification:** Yes No N/A**Weld Procedures Followed:** Yes No N/A**Qualified Welders:** Yes No N/A**Verified Joint Fit-up:** Yes No N/A**Approved Drawings:** Yes No N/A**Approved WPS:** Yes No N/A**Delayed / Cancelled:** Yes No N/A**Bridge No:** 34-0006**Component:** Tower and OBG Components**Summary of Items Observed:**

# WELDING INSPECTION REPORT

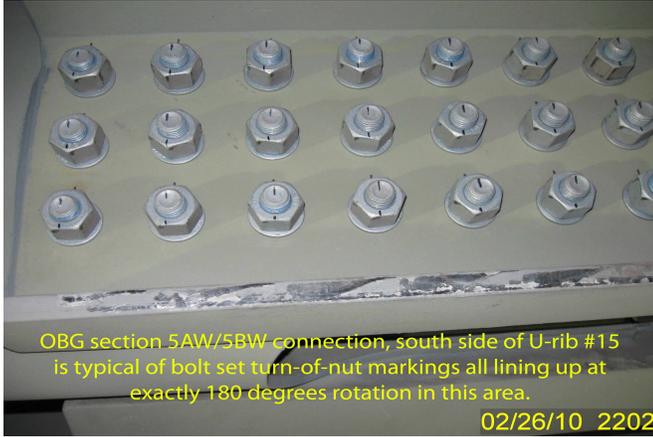
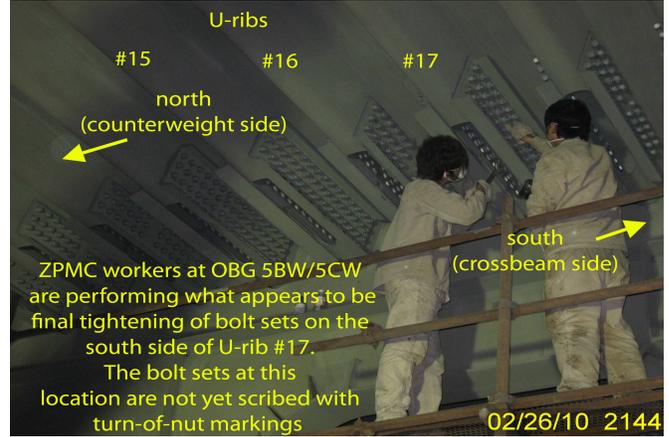
ZPMC workers appearing to be performing what appeared to be final bolt tightening of ASTM A325 bolt sets using a wrench more than one meter long on the 5BW/5CW transverse seam at the deck plate U-rib stiffener lap plates. The workers appeared to be performing final tightening of the nuts to the turn-of-nut specification of 180° to 210°. However, this QA Inspector, George Goulet, observed that the workers were tightening bolts not scribed with in-line turn-of-nut markings from a snug tight condition and another ZPMC worker was following and applying markings at exactly 180° rotation. When this QA Inspector began taking photographs of the procedure being performed she exited OBG section 5W. No ZPMC QC or ABF representative was observed at the location at any time this QA Inspector was present, and although ZPMC QA Inspector Lei Tao (ZPMC QA) had been seen in the area before this QA Inspector was able to observe the above noted action, ZPMC QA was never observed on the scaffold where the work was being performed. This QA Inspector generated an incident report concerning the above noted issue. See the photos below for more information. Additional photos are available.

This QA Inspector attempted to inform ZPMC QA, but the ZPMC QA office was closed at 2300 hours. This QA Inspector notified ZPMC QA Lei Tao at 1925 hours on 2/27/2010.
