DEPARTMENT OF TRANSPORTATION

Contract #: 04-0120F4Cty: SF/ALA Rte: 80 PM: 13.2/13.9File #: 1x.28**WELDING INSPECTION REPORT****Resident Engineer:** Pursell, Gary**Address:** 333 Burma Road**City:** Oakland, CA 94607**Report No:** WIR-012627**Date Inspected:** 12-Mar-2010**Project Name:** SAS Superstructure**OSM Arrival Time:** 700**Prime Contractor:** American Bridge/Fluor Enterprises, a JV**OSM Departure Time:** 1530**Contractor:** American Bridge/Fluor Enterprises, a JV**Location:** Job Site**CWI Name:** Tom Pasqualone**CWI Present:** Yes No**Inspected CWI report:** Yes No N/A**Rod Oven in Use:** Yes No N/A**Electrode to specification:** Yes No N/A**Weld Procedures Followed:** Yes No N/A**Qualified Welders:** Yes No N/A**Verified Joint Fit-up:** Yes No N/A**Approved Drawings:** Yes No N/A**Approved WPS:** Yes No N/A**Delayed / Cancelled:** Yes No N/A**Bridge No:** 34-0006**Component:** OBG Sections**Summary of Items Observed:**

WELDING INSPECTION REPORT

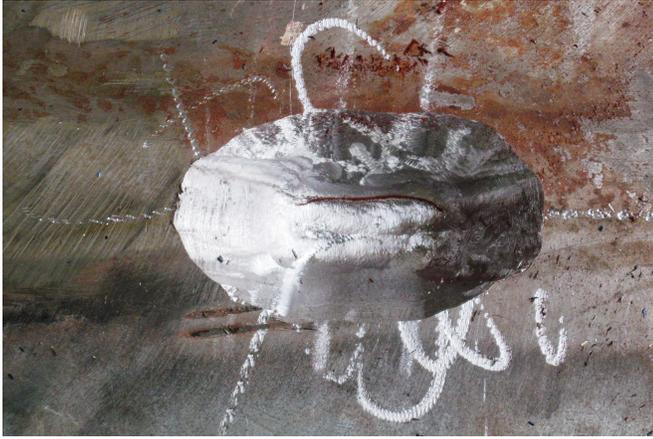
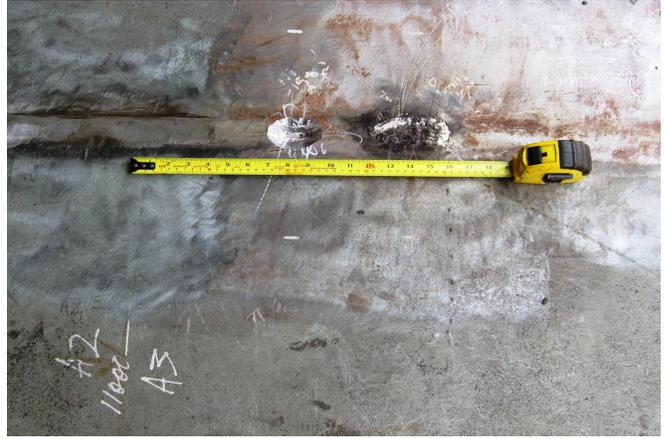
This QA Inspector randomly observed QC Inspector Jesus Cayabyab monitoring the excavation of Repair # 1 on weld E1/E2-A3. This QA Inspector observed welding personnel Mitch Sittinger # 0315 grinding the excavation area. The QA Inspector observed as grinding was performed and QC Inspector Jesus Cayabyab performed various visual and MT inspection to verify the defect had been removed. The area being repaired was previously rejected by QC personnel after performing a UT inspection of the weld. QC Inspector Jesus Cayabyab informed the QA Inspector the defect had been removed. This QA Inspector performed a random visual verification and observed the MT inspection of the excavation prior to welding. The defect appeared to have been removed the only indication observed was the backing bar at the bottom of the weld. Prior to welding the QA Inspector observed QC Inspector Jesus Cayabyab verify the Shielded Metal Arc Welding (SMAW) welding parameters (130 amperes using a 1/8-inch/3.2 mm diameter electrode). The QA Inspector randomly observed the excavation and adjacent

base material was preheated to a temperature greater than 150 degrees F and verified by QC Inspector Jesus Cayabyab by using a temperature indicating marker. The QA Inspector randomly observed welding personnel Mitch Sittinger perform the SMAW welding using preheated E7018-H4R, 3.2 mm diameter electrodes to fill the 70 mm long, 45 mm side and 22 mm deep excavation. Please see attached photos of the excavation to show location and depth of excavation.
