DEPARTMENT OF TRANSPORTATION

Contract #: 04-0120F4Cty: SF/ALA Rte: 80 PM: 13.2/13.9File #: 1.28**WELDING INSPECTION REPORT****Resident Engineer:** Pursell, Gary**Address:** 333 Burma Road**City:** Oakland, CA 94607**Report No:** WIR-012628**Date Inspected:** 11-Mar-2010**Project Name:** SAS Superstructure**OSM Arrival Time:** 900**Prime Contractor:** American Bridge/Fluor Enterprises, a JV**OSM Departure Time:** 1730**Contractor:** American Bridge/Fluor Enterprises, a JV**Location:** Job Site

Bridge No: 34-0006**Component:** Orthotropic Box Girders (OBG)**Summary of Items Observed:**

1) OBG Lift 2W repairs

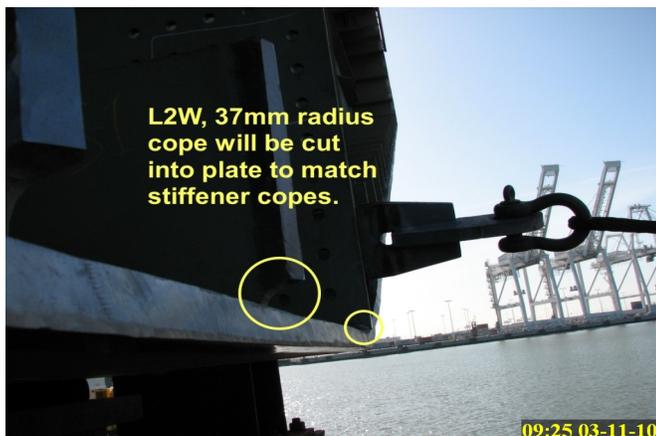
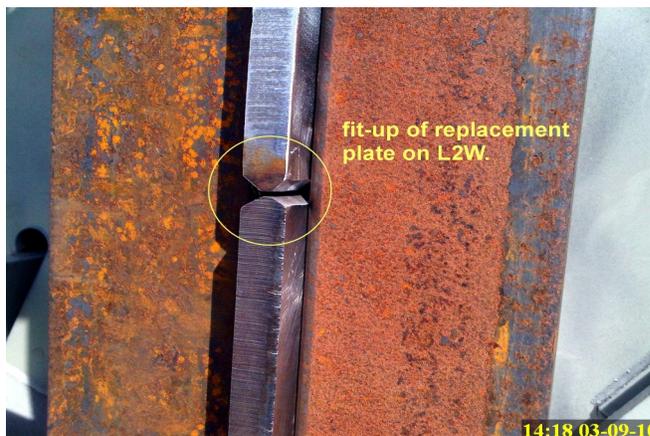
1) The QAI arrived at the ABF facilities at Pier 7 to observe repairs of components on OBG L2W. The QAI observed ABF personnel preparing the replacement plate to be spliced into longitudinal connection plate, line W3, panel point 13. The QAI noted that there was a damaged plate that has been cut out and the base metal is being beveled for the repair splice welding. The QAI also noted that the 18.5mm thick, 675mm tall x 530mm wide replacement plate is cut, beveled and appears to be conforming to the repair procedure specification (ABF weld repair report #201002-001, dated 2-15-2010). The QAI noted that the Quality Control (QC) Inspector William Norris is monitoring the work in progress. The QAI was informed that shielded metal arc welding (SMAW) with 1/8" E7018 electrodes will be used with Welding Procedure Specification (WPS) ABF-WPS-D15-F1200A-1 for the fillet welds and ABF-WPS-D15-1010 for the complete joint penetration (CJP) splice welds. The QAI noted that Al McDaniel, ID 2690, will be making the repair welds. The QAI was shown the repair as it was fit up and was informed by the QC Inspector that it's fit-up is acceptable and will be welded. The QAI noted that the fit-up appeared to be generally conforming to the repair procedure specification. See the attached photo. The QAI made random observations of welding parameters and preheat temperature which were noted as 110 DC amps and a minimum temperature of 70°F. The QAI noted that the fillet welding was in progress at the end of the work shift and the repair was approximately 20% complete. The QAI was informed that this work will continue tomorrow,

During the fit up of the replacement plate, the QAI noted that a 37mm radius weld access hole (cope) was cut into the corner of the plate where it will intersect the OBG L1W/L2W plate D field splice. The QAI was informed that this cope will also be cut into the existing longitudinal connection plate at the opposite side of the OBG segment. See the attached photo. The QAI noted that on OBG L2E there is a similar condition that has been previously reported. The QC Inspector informed the QAI that ABF will cut those copes at a later time.
