DEPARTMENT OF TRANSPORTATION

Contract #: 04-0120F4Cty: SF/ALA Rte: 80 PM: 13.2/13.9File #: 1.28**WELDING INSPECTION REPORT****Resident Engineer:** Pursell, Gary**Address:** 333 Burma Road**City:** Oakland, CA 94607**Report No:** WIR-012631**Date Inspected:** 12-Mar-2010**Project Name:** SAS Superstructure**OSM Arrival Time:** 1300**Prime Contractor:** American Bridge/Fluor Enterprises, a JV**OSM Departure Time:** 2130**Contractor:** American Bridge/Fluor Enterprises, a JV**Location:** Job Site**CWI Name:** See Below**CWI Present:** Yes No**Inspected CWI report:** Yes No N/A**Rod Oven in Use:** Yes No N/A**Electrode to specification:** Yes No N/A**Weld Procedures Followed:** Yes No N/A**Qualified Welders:** Yes No N/A**Verified Joint Fit-up:** Yes No N/A**Approved Drawings:** Yes No N/A**Approved WPS:** Yes No N/A**Delayed / Cancelled:** Yes No N/A**Bridge No:** 34-0006**Component:** Orthotropic Box Girders**Summary of Items Observed:**

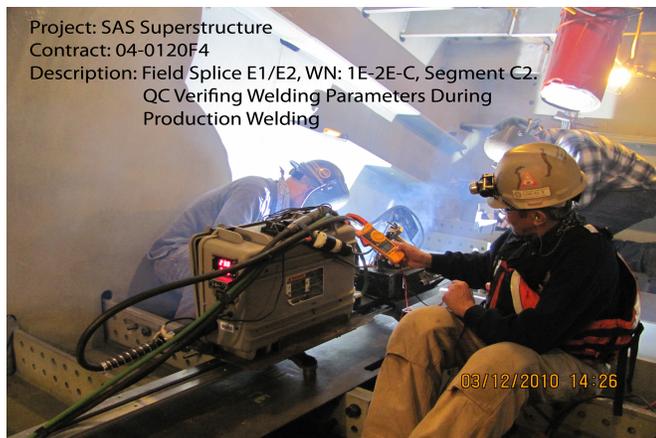
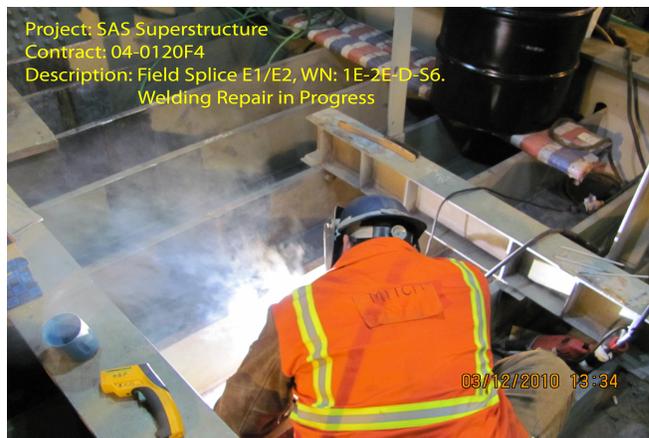
The digital photographs below illustrates the work observed during this shift.
