DEPARTMENT OF TRANSPORTATION

Contract #: 04-0120F4Cty: SF/ALA Rte: 80 PM: 13.2/13.9File #: 1.28**WELDING INSPECTION REPORT****Resident Engineer:** Pursell, Gary**Address:** 333 Burma Road**City:** Oakland, CA 94607**Report No:** WIR-012651**Date Inspected:** 17-Mar-2010**Project Name:** SAS Superstructure**OSM Arrival Time:** 630**Prime Contractor:** American Bridge/Fluor Enterprises, a JV**OSM Departure Time:** 1500**Contractor:** American Bridge/Fluor Enterprises, a JV**Location:** Job Site**CWI Name:** See Below**CWI Present:** Yes No**Inspected CWI report:** Yes No N/A**Rod Oven in Use:** Yes No N/A**Electrode to specification:** Yes No N/A**Weld Procedures Followed:** Yes No N/A**Qualified Welders:** Yes No N/A**Verified Joint Fit-up:** Yes No N/A**Approved Drawings:** Yes No N/A**Approved WPS:** Yes No N/A**Delayed / Cancelled:** Yes No N/A**Bridge No:** 34-0006**Component:** Orthotropic Box Girders (OBG)**Summary of Items Observed:**

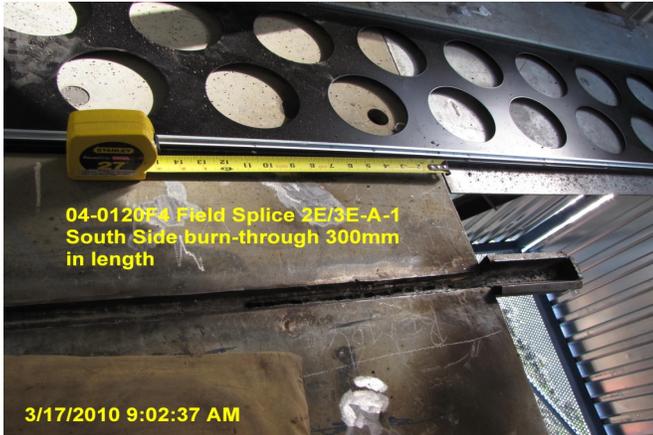
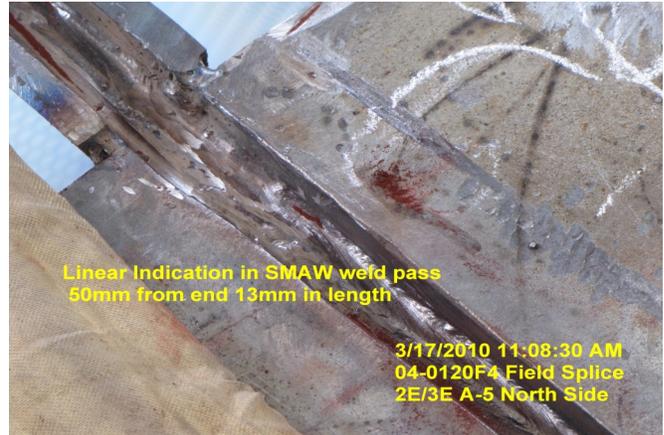
1. OBG Field Splice 2E/3E A1-5 (Deck Plate) in process welding of root
2. OBG Field Splice 1E/2E B-1 Removal of backing bar and Backgouge of side 2 (inside)

The QA inspector periodically observed ABF welding personnel Jordan Hazalaar setting up to perform the root pass of the weld joint utilizing the Submerged Arc Welding (SAW) process by applying the induction heating coils, grinding several areas for leveling purposes and set up of the semi automated equipment. Later in the shift the QA inspector periodically observed the in process SAW of the root pass in which Mr. Hazalaar initiated the welding at the South side of the OBG. After the initial 300mm it became apparent the weld metal burned through the backing bar and the welder ceased the welding operation. It was reviewed by QC inspector Jim Cunningham and the welding foreman Dan Iraci in which Mr. Iraci re-positioned the welder to begin the pass approximately 1.5 M away from the affected area progressing in the Northward direction. The QA inspector reviewed the burn through area and it was relayed the contractor would complete the remaining root pass prior to addressing the damaged area and then begin the restoration of the affected area utilizing Shielded Metal Arc Welding (SMAW). See digital photo included in the body of this report for clarification. The QA inspector periodically observed the SAW of the balance of the root pass for welds designated A1, A2 and A3 by Mr. Hazalaar. The QC inspector Jim Cunningham was noted to be present in order to monitor the progress and ensure the welding was within the established

Welding Procedure Specification (WPS) noted as ABF-WPS-D1.5-4042B-1. The preheat and interpass temperature was verified by the QA inspector to be greater than 65° Celsius (C) and the parameters were verified to be 555 amps, 32.5 volts and a measured travel speed of 380mm/min. The root pass was completed without further issues and was cleaned and presented to QC for performance of Magnetic Particle Testing (MT). The QA inspector observed a portion of the testing performed by QC and noted QC inspectors Tom Pascualone and Jessie Cayabayab assisted Mr. Cunningham. Several areas were marked for minor grinding/blending and the areas we reviewed again and cleared by QC prior to proceeding with a subsequent welding.

During the time of QC performing MT the welder proceeded to remove the affected weld pass for the burn through areas, had QC perform a review and proceeded to restore the area by welding. The welder was performing SMAW with electrode noted as E7018 H4R utilizing the welding parameters from the established WPS noted as ABF-WPS-D1.5-F1200A with 130 amps being verified by QC and QA. This work was not completed by the end of the QA inspector's review and was relayed to QA inspector Dan reyes.

Just prior to the lunch hour the QA inspector observed welding foreman Dan Iraci performing SAW for the subsequent weld pass initiating from approximately 1.5 M from the South side of the OBG. The welder was utilizing the same WPS as previously observed and the welding parameters were measured to be 560 Amps, 32.4 volts and a travel speed of 385mm/min. The preheat was verified to be greater than 65 degrees C by QC and the welder. The work was still in process and appeared to be progressing in general conformance with the contract documents with the exception noted.

The QA inspector periodically observed ABF welding personnel Mitch Sittinger setting up to perform the root pass of the weld joint utilizing the Submerged Arc Welding (SAW) process by applying the induction heating coils, grinding several areas for leveling purposes and set up of the semi automated equipment. Later in the shift the QA inspector periodically observed the in process SAW of the root pass The QC inspector Tom Pascaulaone and Mike Johnson were noted to be present in order to monitor the progress and ensure the welding was within the established Welding Procedure Specification (WPS) noted as ABF-WPS-D1.5-4042B-1. The preheat and interpass temperature was verified by the QA inspector to be greater than 65° Celsius (C) and the parameters were verified to be 560 amps, 32.5 volts and a measured travel speed of 380mm/min. The root pass was completed, cleaned by wire brushing and presented to QC for performance of Magnetic Particle Testing (MT). The QA inspector observed a portion of the testing performed by QC and noted QC inspector Jessie Cayabayab assisting Mr. Pascualone. Several areas were marked for minor grinding/blending and these areas we reviewed again and cleared by QC. Directly prior to the lunch break the QC inspectors discovered a linear indication while perform the MT 50mm from the North side of the OBG weld joint approximately 13mm long located in what appeared to be the SMAW seal weld backing bar pass. See digital photo included in the body of this report for clarification. This information was relayed to QC inspector Mike Johnsoesn who relayed the Welding Quality Control Manager (WQCM) would be contacted for further disposition. The QA inspector relayed this information to the QA lead Bill Levell via phone message. No further work was performed at this location during the QA inspector's review. It was noted however the welding foreman Dan Iraci continued with performing the SAW noted above for weld numbers A2 and A3 during the initial portion of the lunch break with QC inspector Mike Johnson being present. The QA inspector spoke with QA inspector Dan Reyes in which this information was relayed for turnover purposes.

The QA inspector periodically observed ABF welding personnel Sontao Huang performing backgouging operations and the removal of the backing bar utilizing the plasma process. QC inspector Mike Johnson was noted to be present periodically to observe the progress of the work. The work progressed throughout the QA inspector shift, was not completed and appeared to be progressing in general conformance with the contract documents.
