DEPARTMENT OF TRANSPORTATION

Contract #: 04-0120F4Cty: SF/ALA Rte: 80 PM: 13.2/13.9File #: 1.28**WELDING INSPECTION REPORT****Resident Engineer:** Pursell, Gary**Address:** 333 Burma Road**City:** Oakland, CA 94607**Report No:** WIR-012663**Date Inspected:** 15-Mar-2010**Project Name:** SAS Superstructure**OSM Arrival Time:** 700**Prime Contractor:** American Bridge/Fluor Enterprises, a JV**OSM Departure Time:** 1530**Contractor:** American Bridge/Fluor Enterprises, a JV**Location:** Job Site

1) OBG Lift 2W repairs

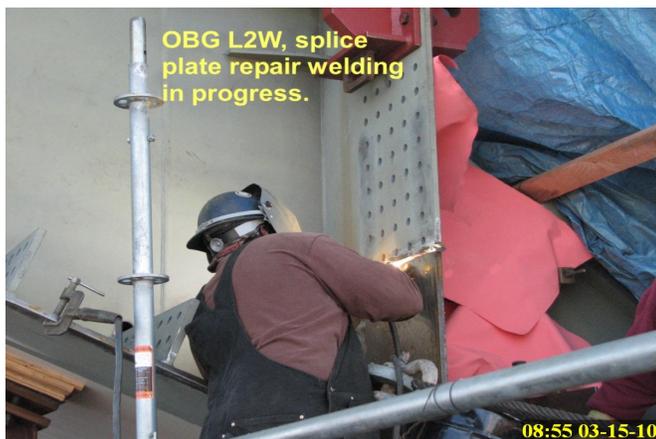
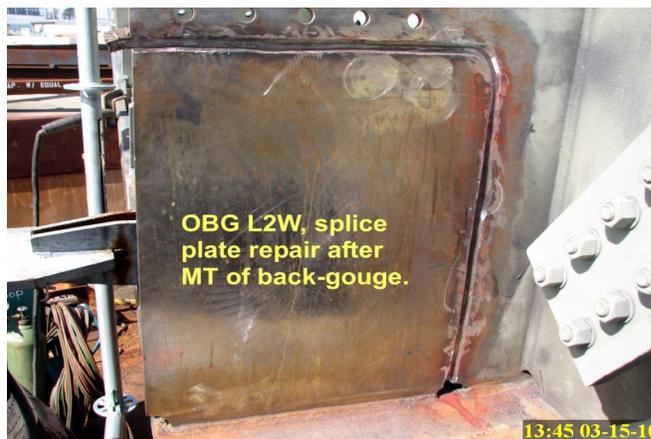
1) The QAI arrived at the ABF facilities at Pier 7 to observe repairs of components on OBG L2W. The QAI observed ABF personnel repairing a damaged section of the OBG Lift 2W. The QAI noted that the original plate has been cut out and the 675mm tall x 530mm wide replacement plate is being spliced into longitudinal connection plate, line W3, panel point 13. The QAI noted that the repair is being performed with repair procedure specification (ABF weld repair report #201002-001, dated 2-15-2010). The QAI noted that the Quality Control (QC) Inspectors William Norris and Bonifacio Daquinag Jr are monitoring the repair welding in progress. The QAI was informed that shielded metal arc welding (SMAW) with 1/8" E7018 electrodes is being used with Welding Procedure Specification (WPS) ABF-WPS-D15-F1200A-1 for the fillet welds and ABF-WPS-D15-1010 for the complete joint penetration (CJP) splice welds. The QAI noted that Al McDaniel, ID 2690 and John Rosas, ID 1480, will be making the repair welds. See the attached photo. The QAI made random observations of welding parameters and preheat temperature which were noted as 120 DC amps and a minimum temperature of 70°F. The QAI was informed that this work will continue tomorrow, 3-12-2010. After the 1st side of the double bevel CJP splice welds were completed, the QAI observed the back-gouged side being inspected in preparation for welding. The QAI witnessed the QC Inspector Bonifacio Daquinag Jr conducting Magnetic Particle Testing (MT). The QAI was informed that the back-gouged joint was ready for additional welding and that no relevant

indications were observed. The QAI conducted verification MT on the back-gouge. See the TL-6028 report for additional information. See the attached photo. The QAI noted that the welding was in progress at the end of the work shift and the repair was approximately 70% complete.
