**DEPARTMENT OF TRANSPORTATION**

Office of Structural Materials

Contract #: 04-0120F4Cty: SF/ALA Rte: 80 PM: 13.2/13.9File #: 1.28**WELDING INSPECTION REPORT****Resident Engineer:** Pursell, Gary**Address:** 333 Burma Road**City:** Oakland, CA 94607**Report No:** WIR-012665**Date Inspected:** 16-Mar-2010**Project Name:** SAS Superstructure**OSM Arrival Time:** 630**Prime Contractor:** American Bridge/Fluor Enterprises, a JV**OSM Departure Time:** 1500**Contractor:** American Bridge/Fluor Enterprises, a JV**Location:** Job Site

## WELDING INSPECTION REPORT

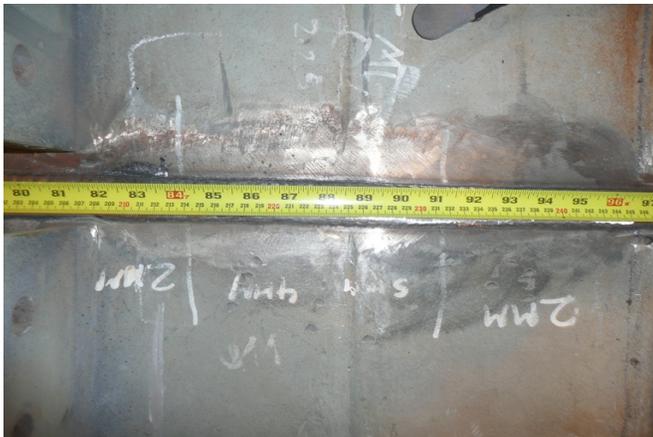
The QA Inspector randomly observed the ABF welders Mitch Sittinger, Song Tao Huang and Huang Jin Quan preparing to continue to perform the FCAW tack weld started on the previous day shift. The QA Inspector observed the induction heat blankets had achieved the minimum required preheat of 150°F for the given thickness of the top deck plate. The QA Inspector observed the ABF welder to be welding the FCAW tack weld utilizing the given parameters of ABF-WPS-D1.5-F3200-2. The QA Inspector randomly verified the FCAW parameters and they were 242 Amps, 22.7 Volts and a travel speed of 425mm/min. The QA Inspector observed the ABF welders join the two top deck plates by welding the bevel to the steel backing bar on both sides of the joint. After the QA Inspector randomly observed the ABF welders join the two members by welding the QA Inspector asked the QC Inspector Tom Pasqualone if the fit up of the weld joint was acceptable (see summary of conversations). The QA Inspector informed the ABF Engineer John Callaghan of the off set issue (see summary of conversations). The Caltrans Structure Material Representative Pat Lowry was on site with the Caltrans Area Construction Manager (ACM) Bill Casey to observe the off set members at 1E/2E-A and 2E/3E-A. The QA Inspector pointed out the off set of the members joined by welding at 1E/2E-C-1 as well as the off set at 2E/3EA-1 and A5 (see summary of conversations). The QA Inspector performed dimensional measurements of the off set at A5 and noted it appeared to be approximately 5mm misaligned and spanning over an area of approximately 75mm beginning at the end of A5 (pictured). The QA Inspector performed dimensional measurements of the off set at A1 and noted it appeared

to be approximately 8mm-4mm misaligned and spanning over and area of 300mm beginning at A1. Upon the arrival of the QA Inspector Danny Reyes, the QA Inspector Rick Bettencourt informed Mr. Reyes of the offset members described above. The QA Inspector noted Mr. Reyes informed the QA Inspector he would write and submit an incident report.

When asked by the QA Inspector, the SE QC Inspector Tom Pasqualone informed the QA Inspector the 2E/3E-A weld joint was not all acceptable due to mismatch on the ends of the joint. The QA Inspector asked the QC Inspector why the ABF welders were joining the members by welding if the fit tolerances were not met. The QC Inspector informed the QA Inspector, the ABF Assistant Welding Superintendent Dan Ieraci instructed the ABF welders to perform the welding.

Mr. Callaghan informed the QA Inspector the off set could not be corrected due to the rigidity of the steel in the corner locations. Mr. Callaghan went on to inform the QA Inspector ABF will not likely perform any transitioning after the weld is completed. The QA Inspector asked Mr. Callaghan to elaborate on why no transitioning by
