**DEPARTMENT OF TRANSPORTATION**

Contract #: 04-0120F4Cty: SF/ALA Rte: 80 PM: 13.2/13.9File #: 69.28**WELDING INSPECTION REPORT****Resident Engineer:** Pursell, Gary**Address:** 333 Burma Road**City:** Oakland, CA 94607**Report No:** WIR-012679**Date Inspected:** 08-Mar-2010**Project Name:** SAS Superstructure**OSM Arrival Time:** 700**Prime Contractor:** American Bridge/Fluor Enterprises, a JV**OSM Departure Time:** 1900**Contractor:** Zhenhua Port Machinery Company, Ltd (ZPMC), Changxing Island **Location:** Shanghai, China**CWI Name:** Xu Xian Ping**CWI Present:** Yes No**Inspected CWI report:** Yes No N/A**Rod Oven in Use:** Yes No N/A**Electrode to specification:** Yes No N/A**Weld Procedures Followed:** Yes No N/A**Qualified Welders:** Yes No N/A**Verified Joint Fit-up:** Yes No N/A**Approved Drawings:** Yes No N/A**Approved WPS:** Yes No N/A**Delayed / Cancelled:** Yes No N/A**Bridge No:** 34-0006**Component:****Summary of Items Observed:**

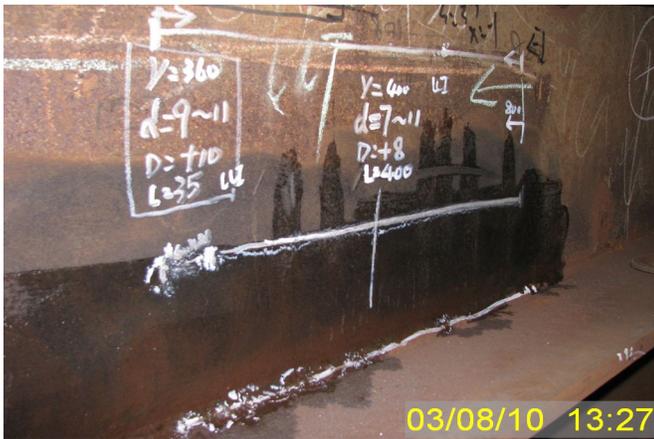
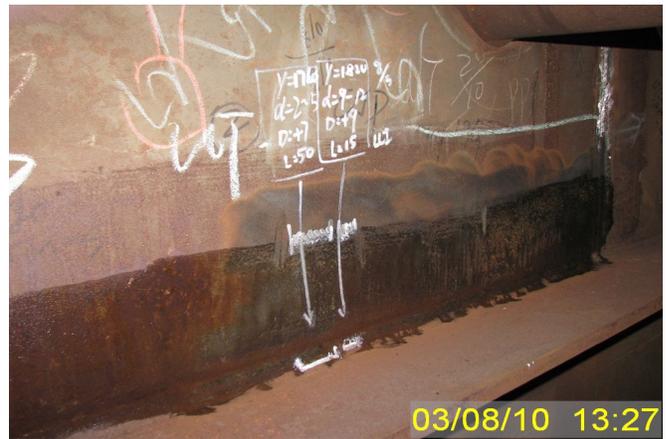
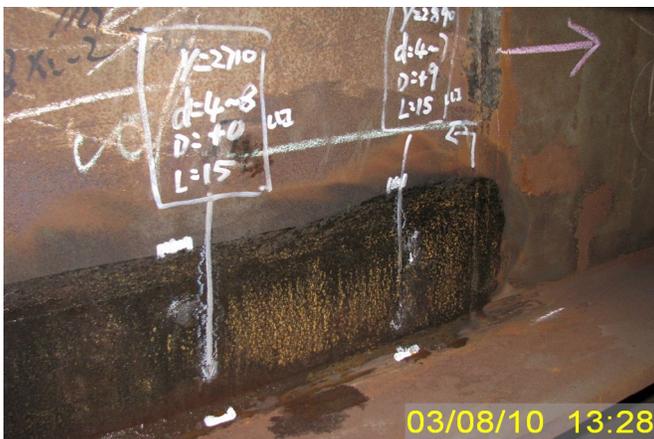
This inspector witnessed conventional ultrasonic inspection, UT, on the complete joint penetration, CJP, portions of the deck panel diaphragm to floor beam flange on section 9EE at panel points 83, 84, and 85. Indications were noted by ABF at the time of inspection, and will be reported on the ABF UT report. ABF UT operators were found to be S021 and S013.
