DEPARTMENT OF TRANSPORTATION

Contract #: 04-0120F4Cty: SF/ALA Rte: 80 PM: 13.2/13.9File #: 69.28**WELDING INSPECTION REPORT****Resident Engineer:** Pursell, Gary**Address:** 333 Burma Road**City:** Oakland, CA 94607**Report No:** WIR-012708**Date Inspected:** 08-Mar-2010**Project Name:** SAS Superstructure**OSM Arrival Time:** 700**Prime Contractor:** American Bridge/Fluor Enterprises, a JV**OSM Departure Time:** 1900**Contractor:** Zhenhua Port Machinery Company, Ltd (ZPMC), Changxing Island **Location:** Shanghai, China**CWI Name:** Li Yang**CWI Present:** Yes No**Inspected CWI report:** Yes No N/A**Rod Oven in Use:** Yes No N/A**Electrode to specification:** Yes No N/A**Weld Procedures Followed:** Yes No N/A**Qualified Welders:** Yes No N/A**Verified Joint Fit-up:** Yes No N/A**Approved Drawings:** Yes No N/A**Approved WPS:** Yes No N/A**Delayed / Cancelled:** Yes No N/A**Bridge No:** 34-0006**Component:** OBG Trial Assembly**Summary of Items Observed:**

Orthotropic Box Girder (OBG) Trial Assembly Areas

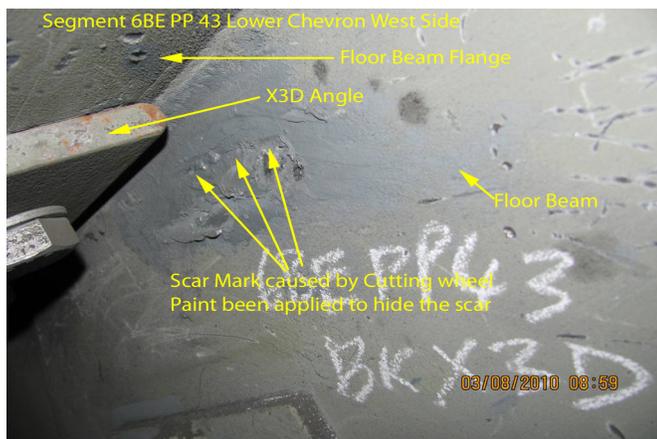
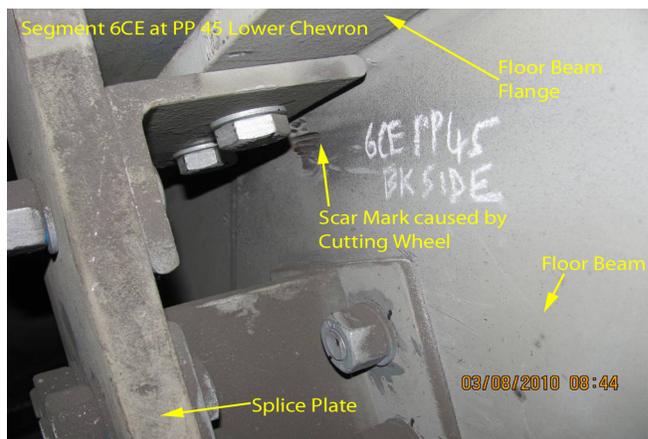
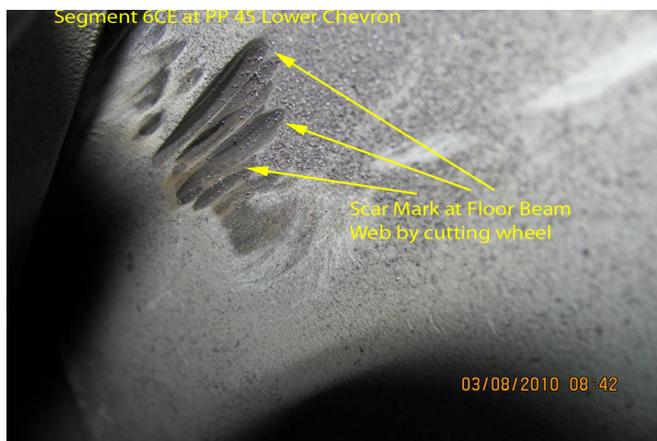
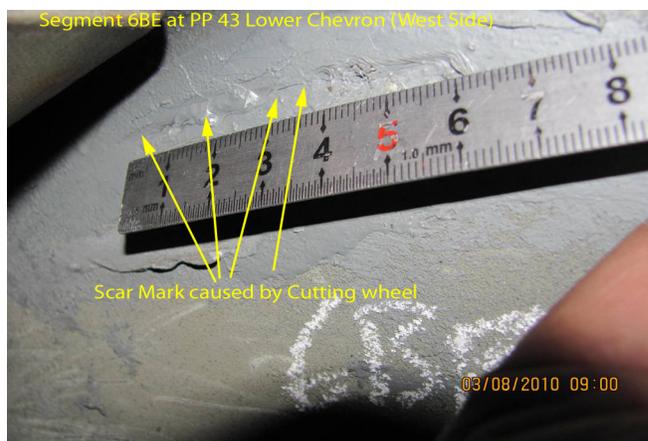
Note: At PP 41 rotation of the nut not offered by ZPMC QC. Note: During verifying the rotation of the nut noticed visually Floor Beam Base material had received scar mark at PP 43 West Side due to cutting of jammed temporary bolt before installing the ASTM A 325 bolt. Please refer the attached pictures below for more comprehensive detail. Details forward to the team leader for further action and added in the punch list.

Note: During verifying the rotation of the nut noticed visually Floor Beam Base material had received scar mark at PP 45 West Side due to cutting of jammed temporary bolt before installing the ASTM A 325 bolt. Please refer the attached pictures below for more comprehensive detail. Details forward to the team leader for further action and added in the punch list.
