DEPARTMENT OF TRANSPORTATION

Contract #: 04-0120F4Cty: SF/ALA Rte: 80 PM: 13.2/13.9File #: 1.28**WELDING INSPECTION REPORT****Resident Engineer:** Pursell, Gary**Address:** 333 Burma Road**City:** Oakland, CA 94607**Report No:** WIR-012728**Date Inspected:** 18-Mar-2010**Project Name:** SAS Superstructure**OSM Arrival Time:** 630**Prime Contractor:** American Bridge/Fluor Enterprises, a JV**OSM Departure Time:** 1500**Contractor:** American Bridge/Fluor Enterprises, a JV**Location:** Job Site

CWI Name:	Bernard Docena, Jesse Cayabayab	CWI Presentation:	Yes	No
Inspected CWI report:	Yes No N/A	Rod Oven in Use:	Yes	No N/A
Electrode to specification:	Yes No N/A	Weld Procedures Followed:	Yes	No N/A
Qualified Welders:	Yes No N/A	Verified Joint Fit-up:	Yes	No N/A
Approved Drawings:	Yes No N/A	Approved WPS:	Yes	No N/A
		Delayed / Cancelled:	Yes	No N/A
Bridge No:	34-0006	Component:	SAS OBG 1E/2E

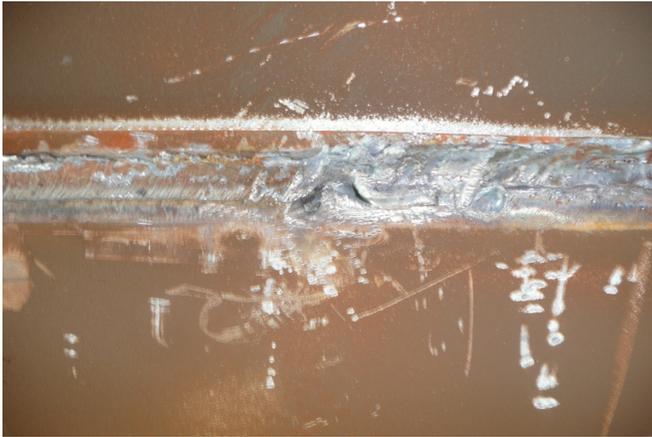
1E/2E -D

operator malfunctioned and sat in one place for too long. The QA Inspector noted a gouge was observed approximately 6mm in depth. The QA Inspector was unable to determine if the gouge was to be removed during the back gouging process, or if it was in the base material (pictured below). The QA Inspector will determine the extent of the gouge when the back gouge is completed. It was observed the back gouging process started on the previous day shift and was still in process at 1100 on today's date. The QA Inspector noted the ABF personnel identified above spent the remainder of the QA Inspectors shift attempting to remove the steel backing bar.
