Contract #: 04-0120F4Cty: SF/ALA Rte: 80 PM: 13.2/13.9File #: 1x.28**WELDING INSPECTION REPORT****Resident Engineer:** Pursell, Gary**Address:** 333 Burma Road**City:** Oakland, CA 94607**Report No:** WIR-012730**Date Inspected:** 18-Mar-2010**Project Name:** SAS Superstructure**OSM Arrival Time:** 700**Prime Contractor:** American Bridge/Fluor Enterprises, a JV**OSM Departure Time:** 1600**Contractor:** American Bridge/Fluor Enterprises, a JV**Location:** Job Site

WELDING INSPECTION REPORT

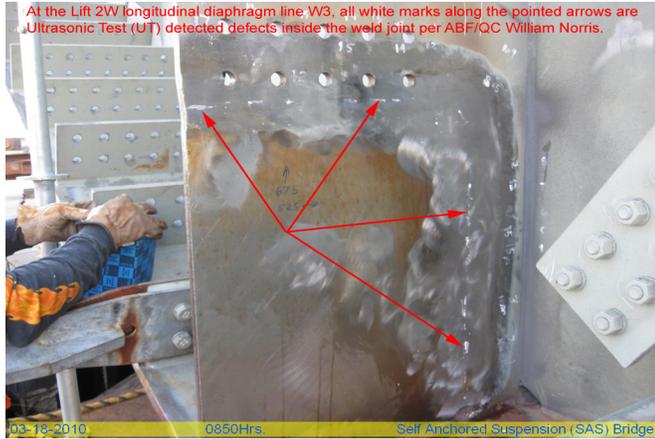
This QA arrived at job site a 7:00 in the morning and went straight to meet the QC and the welders that were fixing the CJP repair at OBG Lift 2W, longitudinal diaphragm line W3. Unfortunately, nobody was seen at the job site so this QA went to QC office and met Mr. Bonifacio Daquinag and William Norris. Mr. Norris informed this QA that QC has already informed ABF/JV about the Ultrasonic Test results and that they are awaiting instruction from ABF/JV since the weld joint was UT rejected.

QA also tried to locate the ABF/JB welding foreman at site to get more information about the rejected weld joint but the foreman was nowhere to find. QA went back to the job site and saw the two welders dismantling the scaffold they used during the weld repair. When QA asked the welders why they are dismantling the scaffolds they responded that they were told that they are not performing the UT repair but preparing for the OBG Lift 2W to be shipped to the actual job site for installation. After knowing all these information, this QA went to the QA site office at Pier 7 and updated QA reports.
