DEPARTMENT OF TRANSPORTATION

Quality Assurance and Source Inspection

Contract #: 04-0120F4Cty: SF/ALA Rte: 80 PM: 13.2/13.9File #: 74.28**WELDING INSPECTION REPORT****Resident Engineer:** Pursell, Gary**Address:** 333 Burma Road**City:** Oakland, CA 94607**Report No:** WIR-012733**Date Inspected:** 04-Mar-2010**Project Name:** SAS Superstructure**OSM Arrival Time:** 750**Prime Contractor:** American Bridge/Fluor Enterprises, a JV**OSM Departure Time:** 1710**Contractor:** Goodwin Steel, UK**Location:** Trentham, UK

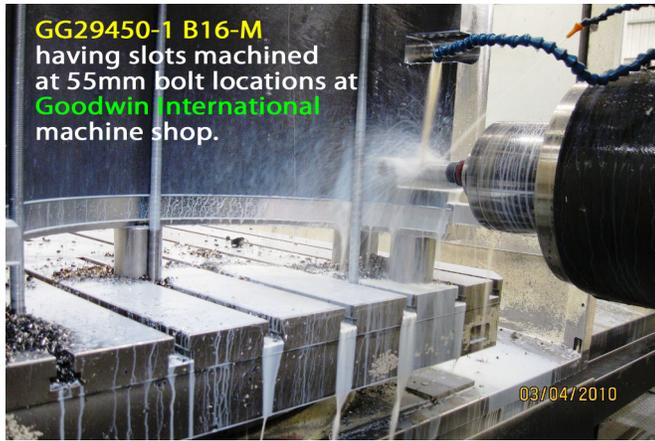
~ GG29450-1, a B16-M cable band half, located at station identified as BTD-4, is being machined at what is known as Joint Face, the slots to the inside of the band at the 55mm bolt boss, area D of Manufacturing Inspection and Test Plan (MITP) 12-02-2009 revision 3. (see photo)

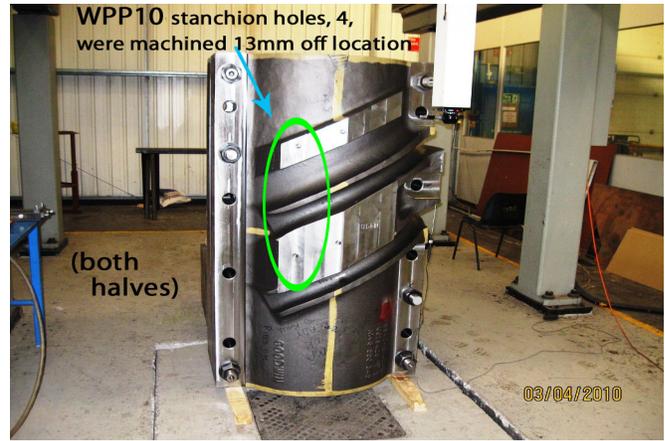
~ WPP10, GG29428-3 and GG29429-1, a B7 type 1 cable band, was observed at the CMM (Coordinate Measuring Machine) for dimensional verification. This QA Inspector noted a disparity in the spread between stanchion holes, speaking with the CMM technician, on Goodwin International's Quality staff, it was a discrepancy previously known to be caused by an input error deriving from "Set out Dimensions" found in table at grid F12 of drawing 5540-B7-1-F/M. The irregularity that was noted, affect both halves. See photo. Mr. Alan Bentley, Quality Director, is still determining the correct course of action.
