DEPARTMENT OF TRANSPORTATION

Contract #: 04-0120F4Cty: SF/ALA Rte: 80 PM: 13.2/13.9File #: 74.28**WELDING INSPECTION REPORT****Resident Engineer:** Pursell, Gary**Address:** 333 Burma Road**City:** Oakland, CA 94607**Report No:** WIR-012734**Date Inspected:** 03-Mar-2010**Project Name:** SAS Superstructure**Prime Contractor:** American Bridge/Fluor Enterprises, a JV**Contractor:** Goodwin Steel, UK**OSM Arrival Time:** 805**OSM Departure Time:** 1620**Location:** Trentham, UK

CWI Name:	N/A	CWI Present:	Yes	No
Inspected CWI report:	Yes No N/A	Rod Oven in Use:	Yes	No N/A
Electrode to specification:	Yes No N/A	Weld Procedures Followed:	Yes	No N/A
Qualified Welders:	Yes No N/A	Verified Joint Fit-up:	Yes	No N/A
Approved Drawings:	Yes No N/A	Approved WPS:	Yes	No N/A
Bridge No:	34-0006	Delayed / Cancelled:	Yes	No N/A
		Component:	Cable Band Castings

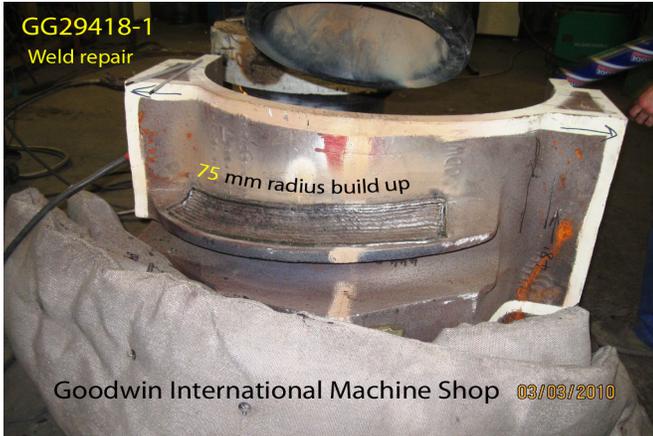
~ GG29418-1 (B2-1-M) This QA Inspector observed welder Dan McDonagh, DM596, performing Shielded Metal Arc (SMAW) process, 5mm, E7018-1 electrode, in the 1G, flat position. Parameters of WPS 04-0120F4B issue 5, were verified and followed, Amp average during observation was 205, voltage was 24.3. Temperature of casting exceeded 170° Celsius (preheat) and was below 371° Celsius for an interpass temperature, these were the actual temperature limits verified by the use of temperature melting sticks. Travel Speed of third pass was approximately 116 mm/min. Excavation in work was identified as #1R, weld build up of 75mm radius. Classified as "Major", on the approved Weld Excavation Map, and will, therefore, be post weld heat treated subsequently. Photo of finished repair is below.
