**DEPARTMENT OF TRANSPORTATION**

Contract #: 04-0120F4Cty: SF/ALA Rte: 80 PM: 13.2/13.9File #: 69.28**WELDING INSPECTION REPORT****Resident Engineer:** Pursell, Gary**Address:** 333 Burma Road**City:** Oakland, CA 94607**Report No:** WIR-012750**Date Inspected:** 17-Feb-2010**Project Name:** SAS Superstructure**OSM Arrival Time:** 700**Prime Contractor:** American Bridge/Fluor Enterprises, a JV**OSM Departure Time:** 1900**Contractor:** Zhenhua Port Machinery Company, Ltd (ZPMC), Changxing Island **Location:** Shanghai, China**CWI Name:** Du Zhi Qun, Li Lin**CWI Present:** Yes No**Inspected CWI report:** Yes No N/A**Rod Oven in Use:** Yes No N/A**Electrode to specification:** Yes No N/A**Weld Procedures Followed:** Yes No N/A**Qualified Welders:** Yes No N/A**Verified Joint Fit-up:** Yes No N/A**Approved Drawings:** Yes No N/A**Approved WPS:** Yes No N/A**Delayed / Cancelled:** Yes No N/A**Bridge No:** 34-0006**Component:** Tower**Summary of Items Observed:**

**SOUTH/NORTH TOWER LIFT 2**

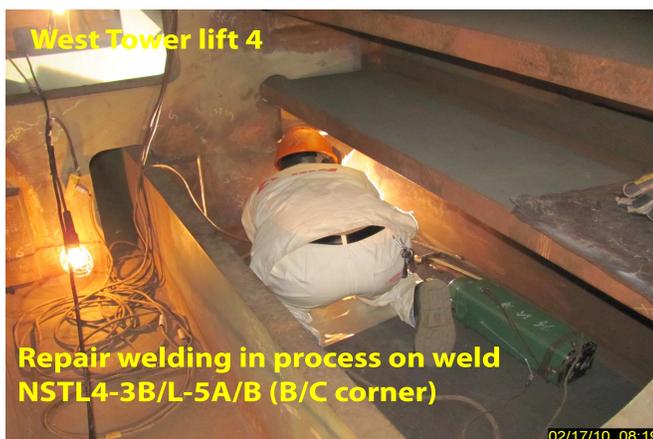
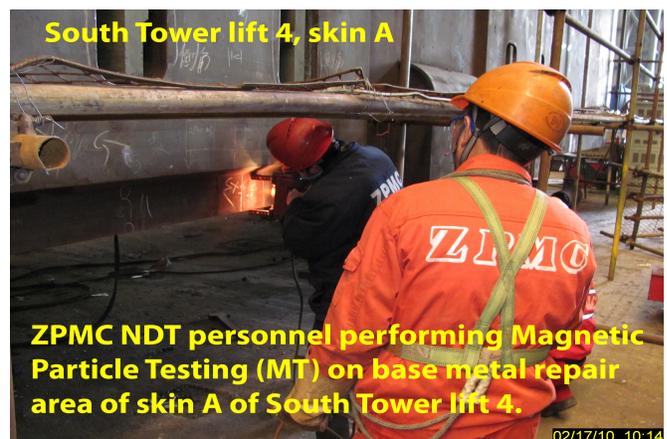
## SOUTH TOWER LIFT 4

During random in process Visual Inspection this Quality Assurance (QA) Inspector observed that ZPMC personnel performing Magnetic Particle Testing (MT) on the base metal repair welded area on skin A of South Tower lift 4. Attached photographs provide additional details.
