DEPARTMENT OF TRANSPORTATION

Contract #: 04-0120F4Cty: SF/ALA Rte: 80 PM: 13.2/13.9File #: 1.28**WELDING INSPECTION REPORT****Resident Engineer:** Pursell, Gary**Address:** 333 Burma Road**City:** Oakland, CA 94607**Report No:** WIR-012770**Date Inspected:** 23-Mar-2010**Project Name:** SAS Superstructure**OSM Arrival Time:** 600**Prime Contractor:** American Bridge/Fluor Enterprises, a JV**OSM Departure Time:** 1500**Contractor:** American Bridge/Fluor Enterprises, a JV**Location:** Job Site

WELDING INSPECTION REPORT

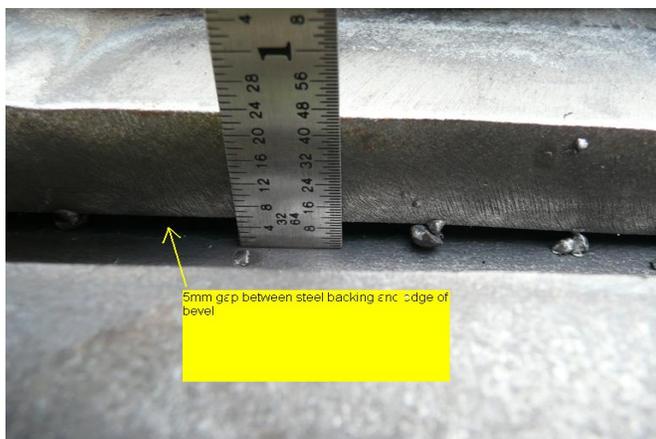
The QA Inspector randomly observed the ABF welders Jordan Hazelaar and James Zhen begin performing SMAW tack welding of the above identified complete joint penetration (CJP) weld joint. The QA Inspector randomly observed and ABF apprentice welder performing preheating tasks utilizing a rose bud torch, heating the base material and steel backing to the minimum required preheat of 150°F. The QA Inspector randomly observed gaps between the steel backing and the edge of the bevel exceeding 2mm (see summary of conversations). The QA Inspector randomly observed the ABF welders performing the SMAW tack welding through out the duration of the shift. The QA Inspector randomly observed and noted the CJP groove weld joint identified above did not appear to meet the general requirements of joint fit up or mismatch in AWS D1.5-02 at the time of the tack

welding. The QA Inspector noted the weld joint was only tacked on one side, so additional fitting tasks could be performed (see summary of conversation).

The QA Inspector was informed by the ABF Engineer John Callaghan no additional fitting tasks could be performed, thus why ABF is depositing the SMAW tack weld or seal pass on the edge of the bevel and the steel backing. The SE QC Inspector Jesus Cayabayab informed the QA Inspector SE is keeping track and mapping the areas of the CJP groove weld, where the gap between the steel backing and the edge of the bevel exceed 2mm for UT purposes. The QC Inspector informed the QA Inspector he would provide the QA Inspector with the map of the areas when it is completed.

The QC Inspector Jesus Cayabayab informed the QA Inspector the fit up of the above identified weld joint had not yet been accepted by SE QC. The QC Inspector went on to inform the QA Inspector, additional fitting tasks would need to be performed.
