**DEPARTMENT OF TRANSPORTATION**

Contract #: 04-0120F4Cty: SF/ALA Rte: 80 PM: 13.2/13.9File #: 69.28**WELDING INSPECTION REPORT****Resident Engineer:** Pursell, Gary**Address:** 333 Burma Road**City:** Oakland, CA 94607**Report No:** WIR-012780**Date Inspected:** 26-Mar-2010**Project Name:** SAS Superstructure**OSM Arrival Time:** 700**Prime Contractor:** American Bridge/Fluor Enterprises, a JV**OSM Departure Time:** 1900**Contractor:** Zhenhua Port Machinery Company, Ltd (ZPMC), Changxing Island **Location:** Shanghai, China**CWI Name:** Li Yang**CWI Present:** Yes No**Inspected CWI report:** Yes No N/A**Rod Oven in Use:** Yes No N/A**Electrode to specification:** Yes No N/A**Weld Procedures Followed:** Yes No N/A**Qualified Welders:** Yes No N/A**Verified Joint Fit-up:** Yes No N/A**Approved Drawings:** Yes No N/A**Approved WPS:** Yes No N/A**Delayed / Cancelled:** Yes No N/A**Bridge No:** 34-0006**Component:** OBG**Summary of Items Observed:**

**TRIAL ASSEMBLY YARD****ULTRASONIC INSPECTION****OBG 9CE**

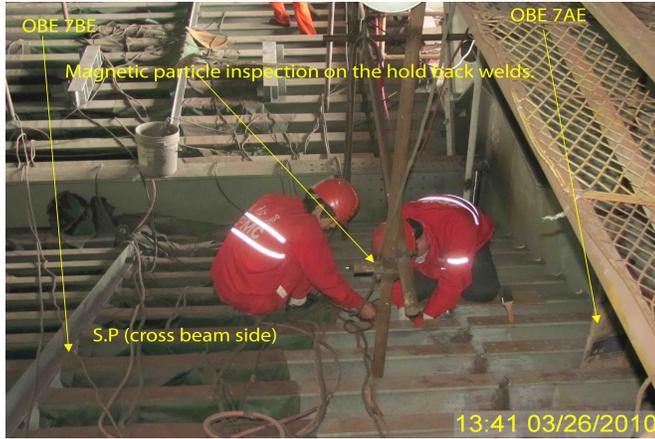
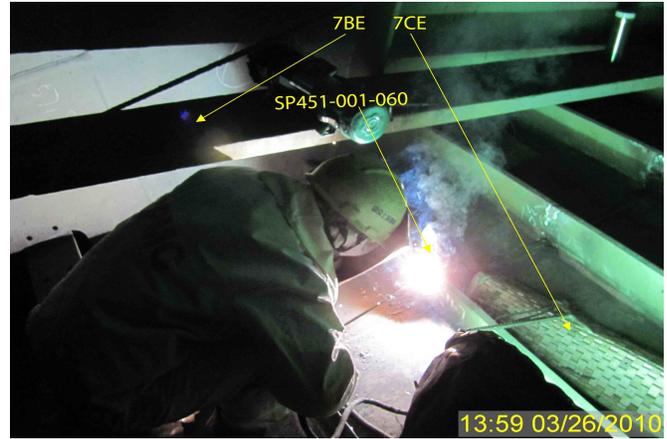
This Quality Assurance (QA) Inspector observed ZPMC qualified welder 066258 performing Shielded Metal Arc Welding process for weld SP451-001-060 located on PCMK. Side panel "I" rib stiffener splice weld (cross beam side). ZPMC QC Mr. Wang Li Yang monitoring this welding. The welding variables recorded by QC appeared to comply with the WPS-345-SAMW-3G (3F)-FCM-Repair. Weld repair report identified as B-WR11359.

This Quality Assurance (QA) Inspector observed ZPMC qualified welder 048659 performing Shielded Metal Arc Welding process for weld OBE7C -010 located on PCMK. Edge panel stiffener splice weld between OBG segment 7BE and 7CE (bike path side). ZPMC QC Mr. Li Yang monitoring this welding. The welding variables recorded by QC appeared to comply with the WPS-345-SAMW-4G (4F)-FCM-Repair. Weld repair report identified as B-WR11363.

This Quality Assurance (QA) Inspector observed ZPMC qualified welder 066361 performing Shielded Metal Arc Welding process for weld CA033-005 located on PCMK. Edge panel to side panel. ZPMC QC Mr. Li Yang monitoring this welding. The welding variables recorded by QC appeared to comply with the WPS-345-SAMW-1G (1F)-FCM-Repair. Weld repair report identified as B-WR11353.

This Quality Assurance (QA) Inspector observed ZPMC qualified welder 066258 performing Shielded Metal Arc Welding process for weld OBE7B-007 located on PCMK. Side panel splice weld between OBG segment 7BE and 7CE (cross beam side). ZPMC QC Mr. Wang Li Yang monitoring this welding. The welding variables recorded by QC appeared to comply with the WPS-345-SAMW-3G (3F)-FCM-Repair.
