**DEPARTMENT OF TRANSPORTATION**

Contract #: 04-0120F4Cty: SF/ALA Rte: 80 PM: 13.2/13.9File #: 1.28**WELDING INSPECTION REPORT****Resident Engineer:** Pursell, Gary**Address:** 333 Burma Road**City:** Oakland, CA 94607**Report No:** WIR-012799**Date Inspected:** 27-Mar-2010**Project Name:** SAS Superstructure**OSM Arrival Time:** 1100**Prime Contractor:** American Bridge/Fluor Enterprises, a JV**OSM Departure Time:** 1900**Contractor:** American Bridge/Fluor Enterprises, a JV**Location:** Job Site**CWI Name:** See Below**CWI Present:** Yes No**Inspected CWI report:** Yes No N/A**Rod Oven in Use:** Yes No N/A**Electrode to specification:** Yes No N/A**Weld Procedures Followed:** Yes No N/A**Qualified Welders:** Yes No N/A**Verified Joint Fit-up:** Yes No N/A**Approved Drawings:** Yes No N/A**Approved WPS:** Yes No N/A**Delayed / Cancelled:** Yes No N/A**Bridge No:** 34-0006**Component:** Orthotropic Box Girders**Summary of Items Observed:**

## WELDING INSPECTION REPORT

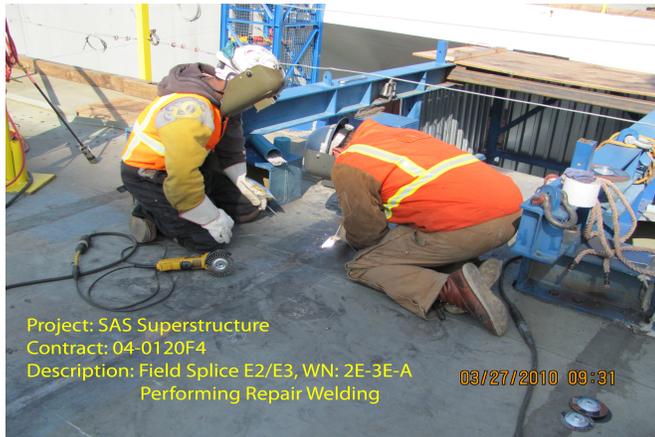
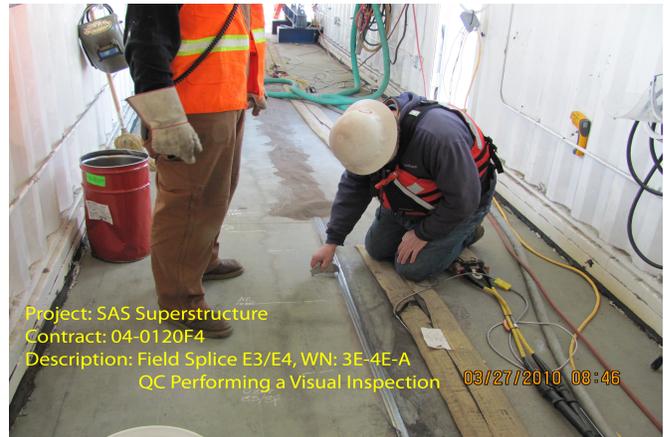
The QAI inspector also observed and noted two areas where the backing bar is not held in intimate contact with the deck plate and exceeded the maximum 2 mm dimension. The QAI has generated a TL-15 Incident Report.

The digital photographs below illustrate the work observed during this scheduled shift.
