Contract #: 04-0120F4Cty: SF/ALA Rte: 80 PM: 13.2/13.9File #: 1.28**WELDING INSPECTION REPORT****Resident Engineer:** Pursell, Gary**Address:** 333 Burma Road**City:** Oakland, CA 94607**Report No:** WIR-012800**Date Inspected:** 24-Mar-2010**Project Name:** SAS Superstructure**OSM Arrival Time:** 600**Prime Contractor:** American Bridge/Fluor Enterprises, a JV**OSM Departure Time:** 1500**Contractor:** American Bridge/Fluor Enterprises, a JV**Location:** Job Site

Bridge No: 34-0006**Component:** SAS OBG 2E/3E-A 3E/4E-A 1W/2W**Summary of Items Observed:**

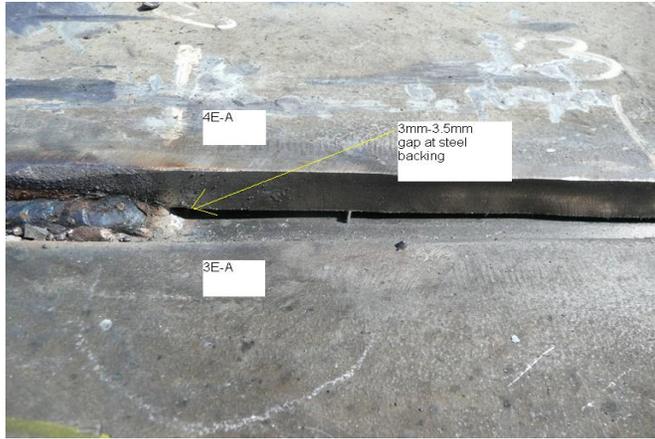
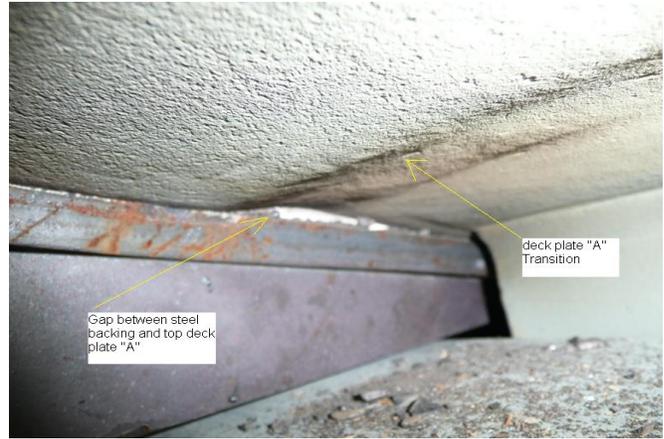
On the previous day shift, the QA Inspector noted the American Bridge/Fluor (ABF) welders had performed shielded metal arc welding (SMAW) tack weld full length of the weld joint on one side only. Upon the arrival of the QA Inspector randomly observed the Smith Emery (SE) Quality Control (QC) Inspectors Jesus Cayabayab and Bnifacio Daquinag performing fit up and dimensional inspections of the above identified weld joint. The QA Inspector randomly observed the SE QC Inspectors indicating and mapping the areas where the gap between the steel backing bar and the bevel exceed 2mm. The QA Inspector performed random dimensional verifications of the fit up of the steel backing in section A2 and A5. The QA Inspector noted a 3mm-3.5mm gap between the steel backing and the bevel between 3500mm-3700mm in section A2. In addition the QA Inspector noted a 3mm-3.5mm gap between the steel backing and the bevel between 700mm-900mm in section A5 (pictured below). The QC Inspector Jesse Cayabayab informed the QA Inspector, all of the areas of the steel backing that exceeded 2mm are being recorded and mapped out for information when ultrasonic testing is performed. The QC Inspector went on to inform the QA Inspector that QC will provide the dimensions and locations on the map to the QA Inspector for future use. The QA Inspector performed a random visual inspection of the steel backing bar from underneath the top deck plate "A". The QA Inspector randomly observed and noted a significant gap between the steel backing bar and the top deck plate at the transition of the deck plates with different thicknesses (pictured below). The QA Inspector was not able to perform a dimensional measurement of the gap due to limited access to the steel

The QA Inspector randomly observed the ABF welders Jordan Hazelaar and James Zhen begin performing SMAW tack welding of the above identified complete joint penetration (CJP) weld joint. The QA Inspector randomly observed and ABF apprentice welder performing preheating tasks utilizing a rose bud torch, heating the base material and steel backing to the minimum required preheat of 150°F. The QA Inspector randomly observed the ABF welders performing the SMAW tack welding through out the duration of the shift. The QA Inspector noted the weld joint was only tacked on both sides of the joint, the QA Inspector noted the two members were joined by welding on this date.

Upon the arrival of the QA Inspector, it was observed 27 total ultrasonic testing (UT) rejections had been located and indicated by the SE QC Inspectors. The QA Inspector noted approximately 18 had been repaired by welding. The QA Inspector noted to SE QC was performed on the QA Inspectors shift. The QA Inspector randomly observed and noted the rejected areas of weld had been indicated with a distinguishing marking directly on the weld. The QA Inspector randomly observed the ABF welder identified as Mitch Sittinger was setting up to begin excavating the previously rejected areas of weld. The QA Inspector randomly observed the ABF welder excavate and repair 1 total rejected area on the QA Inspectors shift (listed below).

The QA Inspector randomly observed the ABF welder begin excavating the UT rejection in A4. The QA Inspector randomly observed the excavation was being performed with a burr bit grinder. After the exaction was complete the QA Inspector randomly observed the SE QC Inspector Tom Pasqualone perform magnetic particle testing of the excavation prior to the repair welding. The QA Inspector noted no relevant indications where located at the time of the testing. The QA Inspector randomly observed the QC Inspector perform the MT and the QA Inspector concurred, no relevant indications appeared to be present at the time of the testing. The QA Inspector noted the excavation was ground to a weldable profile prior to the repair welding. The QA Inspector performed dimensional measurements of the excavation and noted it appeared to be 143mm x 30mm x 14mm. The QA Inspector observed an ABF apprentice welder preheat the isolated area to be welded to the minimum required preheat of 150°F. After the minimum required preheat was achieved, the QA Inspector randomly observed the ABF welder begin the weld repair utilizing the shielded metal arc welding (SMAW) process. The QA Inspector randomly observed the ABF welder utilizing 1/8" E7018 low hydrogen electrodes with 125 Amps. The QA Inspector noted the SMAW parameters and minimum required preheat appeared to be in general compliance with ABF-WPS-D1.5-1000-repair.
