Contract #: 04-0120F4Cty: SF/ALA Rte: 80 PM: 13.2/13.9File #: 1.28**WELDING INSPECTION REPORT****Resident Engineer:** Pursell, Gary**Address:** 333 Burma Road**City:** Oakland, CA 94607**Report No:** WIR-012804**Date Inspected:** 25-Mar-2010**Project Name:** SAS Superstructure**OSM Arrival Time:** 630**Prime Contractor:** American Bridge/Fluor Enterprises, a JV**OSM Departure Time:** 1500**Contractor:** American Bridge/Fluor Enterprises, a JV**Location:** Job Site

CWI Name:	Bernard Docena, Jesse Cayabayab			CWI Presentation:	Yes	No	
Inspected CWI report:	Yes	No	N/A	Rod Oven in Use:	Yes	No	N/A
Electrode to specification:	Yes	No	N/A	Weld Procedures Followed:	Yes	No	N/A
Qualified Welders:	Yes	No	N/A	Verified Joint Fit-up:	Yes	No	N/A
Approved Drawings:	Yes	No	N/A	Approved WPS:	Yes	No	N/A
				Delayed / Cancelled:	Yes	No	N/A
Bridge No:	34-0006			Component:	SAS OBG 2E/3E-A,F

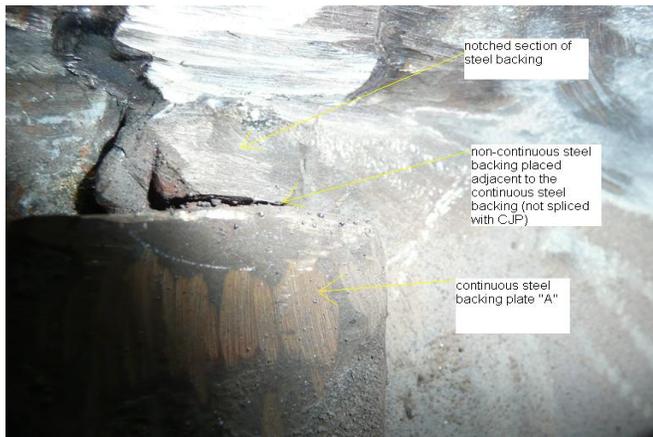
2E-3E-F

The QA Inspector randomly observed the steel backing attached on the bottom side of the top deck plate identified as "A" did not appear to be continuous. The QA Inspector randomly observed the steel backing was continuous through out the majority of the top deck plate except for the ends. The QA Inspector randomly observed the steel backing near the ends of the "A" joint where the steel backing meets the "B" and "F" vertical corner joint assemblies, to be butted up and not welded (pictured). The QA Inspector noted it appears a piece of notched steel backing was slid through the root opening of the vertical "B" and "F" CJP grooves prior to welding and butted up to the continuous steel backing of the "A" plate. The QA Inspector noted an incident report was written and submitted for the above identified issue.
