**DEPARTMENT OF TRANSPORTATION**

Contract #: 04-0120F4Cty: SF/ALA Rte: 80 PM: 13.2/13.9File #: 1.28**WELDING INSPECTION REPORT****Resident Engineer:** Pursell, Gary**Address:** 333 Burma Road**City:** Oakland, CA 94607**Report No:** WIR-012812**Date Inspected:** 29-Mar-2010**Project Name:** SAS Superstructure**OSM Arrival Time:** 1200**Prime Contractor:** American Bridge/Fluor Enterprises, a JV**OSM Departure Time:** 2030**Contractor:** American Bridge/Fluor Enterprises, a JV**Location:** Job Site**CWI Name:** See Below**CWI Present:** Yes No**Inspected CWI report:** Yes No N/A**Rod Oven in Use:** Yes No N/A**Electrode to specification:** Yes No N/A**Weld Procedures Followed:** Yes No N/A**Qualified Welders:** Yes No N/A**Verified Joint Fit-up:** Yes No N/A**Approved Drawings:** Yes No N/A**Approved WPS:** Yes No N/A**Delayed / Cancelled:** Yes No N/A**Bridge No:** 34-0006**Component:** Orthotropic Box Girders**Summary of Items Observed:**

# WELDING INSPECTION REPORT

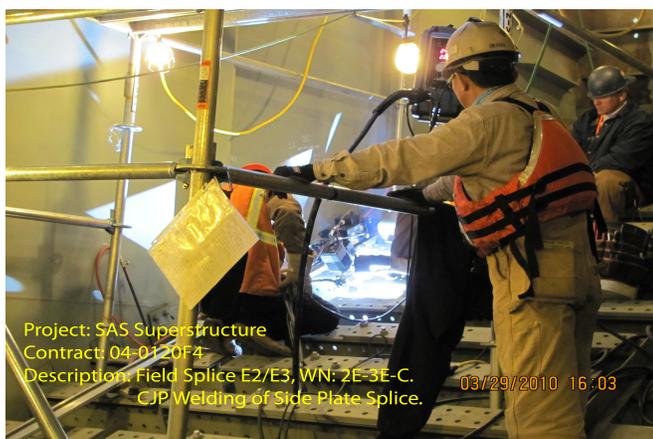
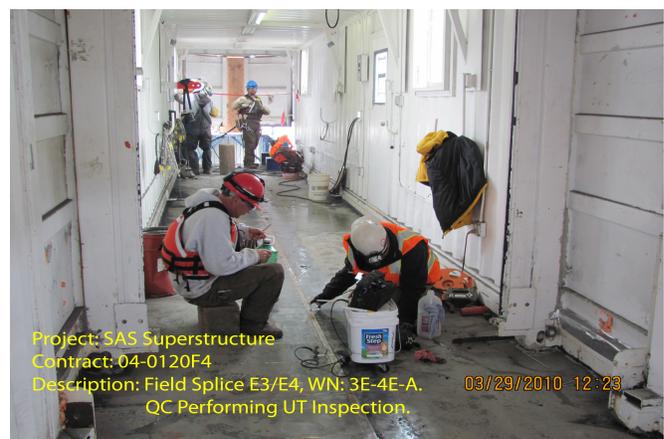
The digital photographs below illustrate the work observed during this scheduled shift.
