**DEPARTMENT OF TRANSPORTATION**

Contract #: 04-0120F4Cty: SF/ALA Rte: 80 PM: 13.2/13.9File #: 1x.28**WELDING INSPECTION REPORT****Resident Engineer:** Pursell, Gary**Address:** 333 Burma Road**City:** Oakland, CA 94607**Report No:** WIR-012814**Date Inspected:** 24-Mar-2010**Project Name:** SAS Superstructure**OSM Arrival Time:** 1200**Prime Contractor:** American Bridge/Fluor Enterprises, a JV**OSM Departure Time:** 1730**Contractor:** American Bridge/Fluor Enterprises, a JV**Location:****CWI Name:** Steve McConnell**CWI Present:** Yes No**Inspected CWI report:** Yes No N/A**Rod Oven in Use:** Yes No N/A**Electrode to specification:** Yes No N/A**Weld Procedures Followed:** Yes No N/A**Qualified Welders:** Yes No N/A**Verified Joint Fit-up:** Yes No N/A**Approved Drawings:** Yes No N/A**Approved WPS:** Yes No N/A**Delayed / Cancelled:** Yes No N/A**Bridge No:** 34-0006**Component:** OBG Sections**Summary of Items Observed:**

# WELDING INSPECTION REPORT

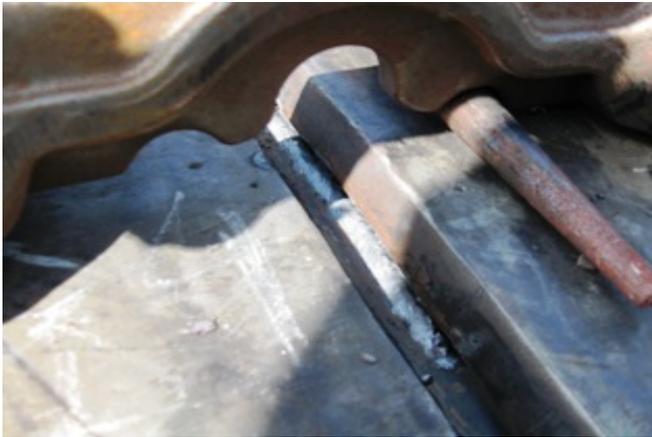
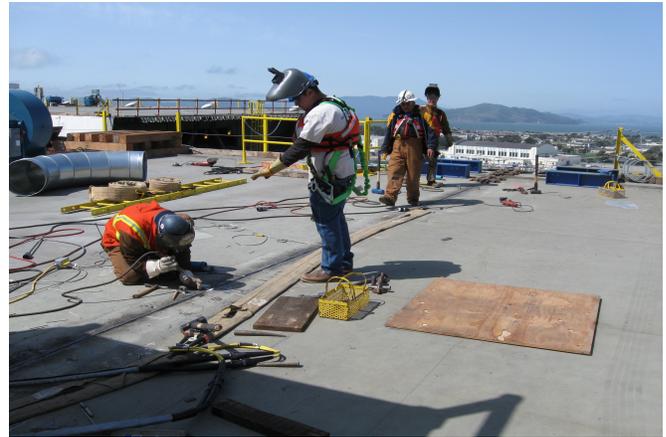
This QA Inspector randomly observed QC Inspector Bonifacio Daquinag monitoring the fit up and SMAW welding being performed at weld joint E3/E4-A1 thru 5. The QA Inspector randomly observed welding personnel Jordan Hazelaar # 2135 and James Zhen # 6001 using the SMAW process to produce intermittent fillet welds on each side of joint bevel as QC Inspector Bonifacio Daquinag verified the fit up was within tolerance. See photo below. The QA Inspector randomly observed as QC Inspector Bonifacio Daquinag monitored the welding parameters of each welding personnel. Both welding personnel were observed using approximately 130 amperes and 3.2 mm diameter electrodes. The welding observed appeared to be within the parameters of WPS – ABF-WPS-D15-F1200A. The QA Inspector observed the fit up of the weld joint and observed the offset at E3/E4-A5 (adjacent to the side plate) appeared to exceed the allowable tolerance. QC Inspector Bonifacio Daquinag observed the QA Inspector measuring the offset at this area and verbally confirmed the offset was approximately 10 mm. QC Inspector Bonifacio Daquinag stated welding would not be performed where the fit up exceeded tolerance specifically specifying this area. Later in the shift the QA Inspector observed welding personnel James Zhen # 6001 using the SMAW process to deposit weld metal on the backing bar in what appeared to be a buttering weld to build up the area between the backing bar the bottom of the plate at E3/E4-A5 (adjacent to the side plate). See photo below. The QA Inspector observed QC Inspector Bonifacio Daquinag at the other end of the deck weld and asked if he was aware of the welding being performed at E3/E4-A5 (adjacent to the side plate) and he stated the welding personnel had informed him a Request For Information had been submitted previously this date addressing the issue and had been instructed by their supervisor to proceed with the welding prior to receiving an answer on the RFI. This QA Inspector contacted Shift Lead QA Inspector Danny Reyes and informed him of the observation and conversations noted above.
