DEPARTMENT OF TRANSPORTATION

Contract #: 04-0120F4Cty: SF/ALA Rte: 80 PM: 13.2/13.9File #: 1.28**WELDING INSPECTION REPORT****Resident Engineer:** Pursell, Gary**Address:** 333 Burma Road**City:** Oakland, CA 94607**Report No:** WIR-012840**Date Inspected:** 30-Mar-2010**Project Name:** SAS Superstructure**OSM Arrival Time:** 700**Prime Contractor:** American Bridge/Fluor Enterprises, a JV**OSM Departure Time:** 1530**Contractor:** American Bridge/Fluor Enterprises, a JV**Location:** Job Site**CWI Name:** See Below**CWI Present:** Yes No**Inspected CWI report:** Yes No N/A**Rod Oven in Use:** Yes No N/A**Electrode to specification:** Yes No N/A**Weld Procedures Followed:** Yes No N/A**Qualified Welders:** Yes No N/A**Verified Joint Fit-up:** Yes No N/A**Approved Drawings:** Yes No N/A**Approved WPS:** Yes No N/A**Delayed / Cancelled:** Yes No N/A**Bridge No:** 34-0006**Component:** Orthotropic Box Girders (OBG)**Summary of Items Observed:**

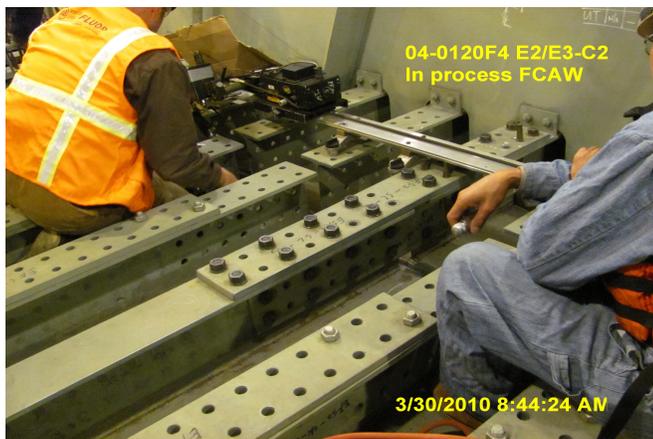
Field Splice 3E/4E Face B-1

within the established Welding Procedure Specification (WPS) noted as ABF-WPS-D1.5-3042A-1. The preheat and interpass temperature was verified by the QC and QA inspector to be greater than 93° Celsius (C) and the parameters were verified to be 250 amps, 24.2 volts and a measured travel speed of 260mm/min. The welder is in the process of placing the fill passes at this time. A digital photo is included in the body of this report for general information.

The work progressed throughout the morning shift and just prior to the lunch break the welder was noted to be placing the final cover pass in this area and relayed to the QA inspector he would be relocating further up the side plate to approximately Y location 5200mm – 2700mm. The work appeared to be progressing in general conformance with the contract documents.
