DEPARTMENT OF TRANSPORTATION

Contract #: 04-0120F4Cty: SF/ALA Rte: 80 PM: 13.2/13.9File #: 1x.28**WELDING INSPECTION REPORT****Resident Engineer:** Pursell, Gary**Address:** 333 Burma Road**City:** Oakland, CA 94607**Report No:** WIR-012841**Date Inspected:** 30-Mar-2010**Project Name:** SAS Superstructure**OSM Arrival Time:** 1200**Prime Contractor:** American Bridge/Fluor Enterprises, a JV**OSM Departure Time:** 2030**Contractor:** American Bridge/Fluor Enterprises, a JV**Location:** Job Site

CWI Name:	Jesus Cayabyab and Jim Cunningham			CWI Present:	Yes	No	
Inspected CWI report:	Yes	No	N/A	Rod Oven in Use:	Yes	No	N/A
Electrode to specification:	Yes	No	N/A	Weld Procedures Followed:	Yes	No	N/A
Qualified Welders:	Yes	No	N/A	Verified Joint Fit-up:	Yes	No	N/A
Approved Drawings:	Yes	No	N/A	Approved WPS:	Yes	No	N/A
				Delayed / Cancelled:	Yes	No	N/A
Bridge No:	34-0006			Component:	Orthotropic Box Girder

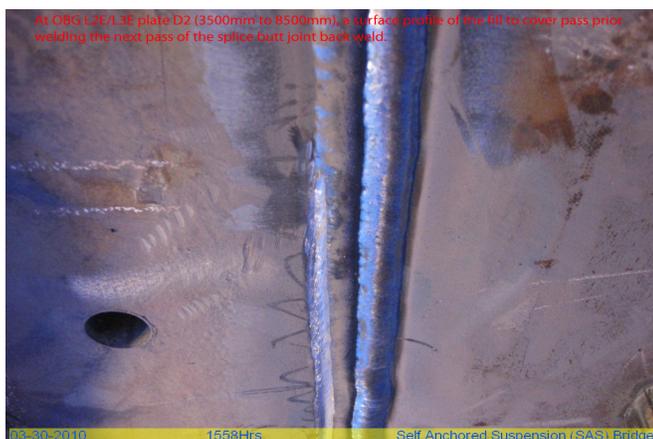
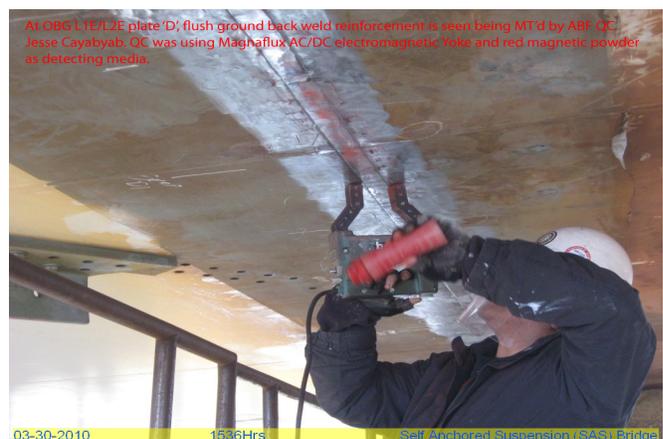
QA randomly observed ABF/JV qualified welders Rory Hogan (ID #3186) and Jeremy Dolman (ID #5042) continue perform CJP groove (splice) back welding fill pass on Orthotropic Box Girder (OBG) L2E/L3E plate 'D2' (3500mm to 8500mm). The welders were observed welding in the 4G (overhead) position utilizing a dual shield Flux Cored Arc Welding (FCAW-G) with E71T-1M, 1/16" diameter wire electrode and implementing Caltrans approved Welding Procedure Specification (WPS) ABF-WPS-D15-3040A-4. The welder was using a track mounted welder holder assembly that is remotely controlled. The joint being welded has the backing bar gouged using the Esab Plasma Arc machine and was ground smooth. The gouged and ground splice butt joint was also Non Destructive Testing (NDT) tested using the Magnetic Particle Testing (MT) which was performed and accepted by ABF QC Jim Cunningham prior welding. The splice joint was preheated to greater than 150 degree Fahrenheit prior welding and the vicinity was properly protected from wind. During welding, ABF Quality Control (QC) Jim Cunningham was noted monitoring the welding parameters of the welder. QA performed parameter check readings during welding and noted the following: 250 amperes, 23.0 volts with travel speed of 154 mm per minute travel speed which are deemed acceptable to contract specifications. During random observation, QA noted fill to cover passes were welded into the joint without any major issues. Completed fill passes noted at the time deemed acceptable to contract specifications.

At OBG L1W/L2W plate 'D' inside the box, QA performed alignment check on the fit up of the splice butt joint.

Three locations in between the stiffener plates were measured from North to South and the following measurements (in millimeters) were noted;

1. D1: 6.0 3.5 3.0 D11: 2.0 1.0 1.5
2. D2: 2.0 2.0 2.0 D12: 2.0 2.0 1.0
3. D3: 2.5 2.0 2.0 D13: 2.0 1.5 1.0
4. D4: 2.0 1.0 1.0 D14: 1.0 1.0 0.0
5. D5: 2.0 1.5 1.0 D15: 1.0 1.0 0.0
6. D6: 2.0 2.5 2.0 D16: 1.0 1.0 2.0
7. D7: 2.0 2.0 0.0 D17: 2.0 2.0 1.0
8. D8: 1.0 0.0 0.0 D18: 2.0 1.5 1.5
9. D9: 1.5 1.0 2.0 D19: 1.0 0.0 0.0
10. D10: 1.0 1.5 2.0

According to ABF QC Jesus Cayabyab, location D1 mentioned above wherein the offset measurement is 6.0mm will be requested with Request for Information (RFI) due to limited room for correction.

Also at L1W/L2W plate 'C' inside the box, QA performed alignment check on the fit up of the splice butt joint. All the measurements were good (less than 2.0mm) except on three areas; 1 – where the bottom part is connected to the D1 plate wherein it has 6.0mm offset; 2 – near stiffener #3 from bottom wherein it has an offset of 3.0mm and 3 – near stiffener #4 from bottom wherein it has an offset of 4.0mm.

In another OBG location, OBG L1E/L2E plate 'D', QAI observed ABF QC personnel Jesus Cayabyab perform Magnetic Particle Testing (MT) on the flush ground back weld reinforcement of the splice joint. The ABF QC was using a Magnaflux AC/DC electromagnetic yoke with serial number 517750 and red magnetic powder as detecting media. After completing the MT, ABF QC informed this QAI that they are rejecting the flush ground back weld reinforcement due to the presence of slag and underfill on the weld. On one area of the joint, QA also noted a disc shape ground area wherein the center has 2.0mm below the base metal. QC also informed QA that he is rejecting this over ground weld.
