DEPARTMENT OF TRANSPORTATION

Office of Structural Materials

Contract #: 04-0120F4Cty: SF/ALA Rte: 80 PM: 13.2/13.9File #: 1.28**WELDING INSPECTION REPORT****Resident Engineer:** Pursell, Gary**Address:** 333 Burma Road**City:** Oakland, CA 94607**Report No:** WIR-012842**Date Inspected:** 31-Mar-2010**Project Name:** SAS Superstructure**OSM Arrival Time:** 1200**Prime Contractor:** American Bridge/Fluor Enterprises, a JV**OSM Departure Time:** 2030**Contractor:** American Bridge/Fluor Enterprises, a JV**Location:** Job Site**CWI Name:** See Below**CWI Present:** Yes No**Inspected CWI report:** Yes No N/A**Rod Oven in Use:** Yes No N/A**Electrode to specification:** Yes No N/A**Weld Procedures Followed:** Yes No N/A**Qualified Welders:** Yes No N/A**Verified Joint Fit-up:** Yes No N/A**Approved Drawings:** Yes No N/A**Approved WPS:** Yes No N/A**Delayed / Cancelled:** Yes No N/A**Bridge No:** 34-0006**Component:** Orthotropic Box Girders**Summary of Items Observed:**

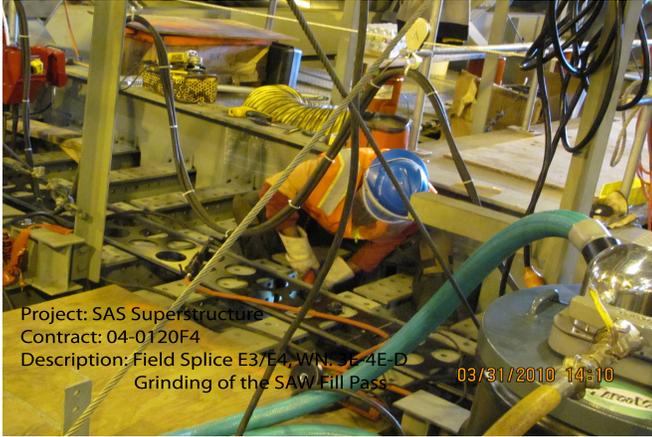
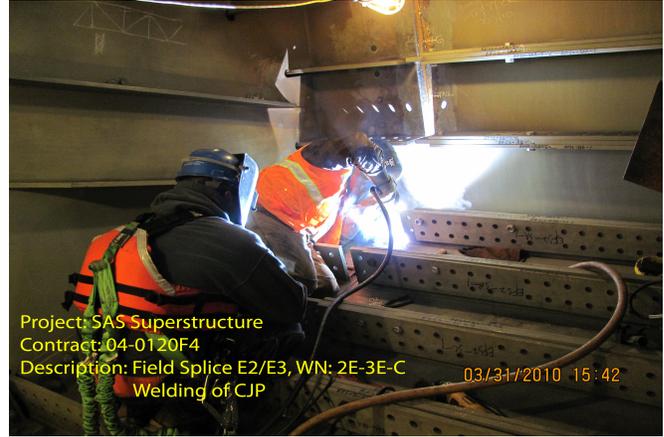
The QAI observed at periodic intervals, the Submerged Arc Welding (SAW) of the bottom plate field splice identified as Weld Number (WN): 3E-4E-D. The welding was performed by the AB/F welding personnel Daniel Ieraci ID-3232, utilizing the Welding Procedure Specification (WPS) ABF-WPS-D15-4042B-1 Rev. 0. The WPS was also used by AB/F Quality Control (QC) Inspector Tom Pasqualone to perform QC verification of the Direct Current Electrode Positive (DCEP) welding parameters during the Complete Joint Penetration (CJP) groove welding of the bottom plate field splice. Later in the shift the QAI observed the QC inspector verifying the welding parameters of each welder and were noted as follows: 550 amps, 32.5 volts and a travel speed measured at 381 mm/minute. The QC inspector also monitored the surface temperatures during the field welding and the following was observed and noted by the QAI: the minimum preheat temperature of 60 degrees Celsius and the maximum interpass temperature of 230 degrees Celsius.

informed the QAI at the conclusion of welding the third pass the QC inspector noted slag was trapped at the toe of the weld. At the request of the QC inspector the welding supervisor instructed AB/F personnel to the remove the slag by machining the areas utilizing a grinder. This work was not completed during this shift.

The QAI observed the automated FCAW-G welding process during the CJP welding of the side plate field splice performed by Mitch Sittinger ID-0315 and Songtao Huang ID-3794. The welders utilized the FCAW-G welding process as per the WPS ABF-WPS-D15-3042A-4 Rev. 0 which was also used as a reference by the Quality Control (QC) inspector Bernie Docena to verify the welding parameters and the surface temperatures during the welding operation. The DCEP welding parameters were verified and noted by the QC inspector and were noted as follows: 256 amps, 24.3 volts and a travel speed measured at 290 mm/minute. The minimum preheat temperature of 60 degrees Celsius and the maximum interpass temperature of 230 degrees Celsius were maintained. The QAI inspector also noted that the root opening was approximately 5mm. In Conversation, regarding this issue, the QAI was informed by the QC that he was aware of this field condition and the root opening required additional grinding to meet the minimum requirements of the contract documents. This as built condition is located 300mm from the edge plate identified as "B" and measured approximately 914mm.

The digital photographs on page 2 of this report illustrates the work observed during this scheduled shift.
