DEPARTMENT OF TRANSPORTATION

Contract #: 04-0120F4Cty: SF/ALA Rte: 80 PM: 13.2/13.9File #: 13.28**WELDING INSPECTION REPORT****Resident Engineer:** Pursell, Gary**Address:** 333 Burma Road**City:** Oakland, CA 94607**Report No:** WIR-012848**Date Inspected:** 25-Mar-2010**Project Name:** SAS Superstructure**OSM Arrival Time:** 1000**Prime Contractor:** American Bridge/Fluor Enterprises, a JV**OSM Departure Time:** 1830**Contractor:** Oregon Iron Works Clackamas, Or.**Location:** Clackamas, OR**CWI Name:** M. Gregson, J. Salazar**CWI Present:** Yes No**Inspected CWI report:** Yes No N/A**Rod Oven in Use:** Yes No N/A**Electrode to specification:** Yes No N/A**Weld Procedures Followed:** Yes No N/A**Qualified Welders:** Yes No N/A**Verified Joint Fit-up:** Yes No N/A**Approved Drawings:** Yes No N/A**Approved WPS:** Yes No N/A**Delayed / Cancelled:** Yes No N/A**Bridge No:** 34-0006**Component:** Hinge K Pipe Beams**Summary of Items Observed:**

Hinge-K Pipe Beam Assembly 101A-1:

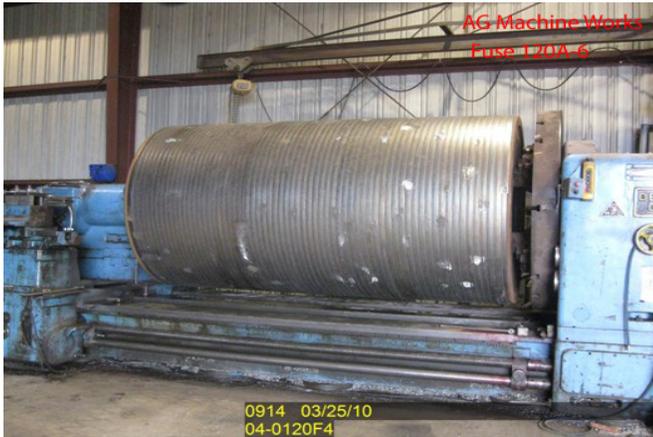
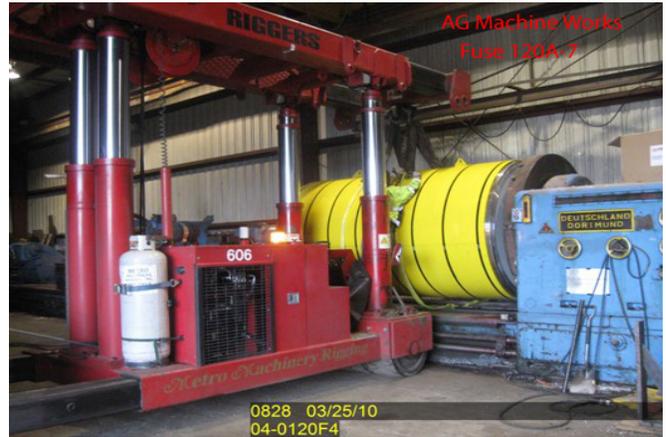
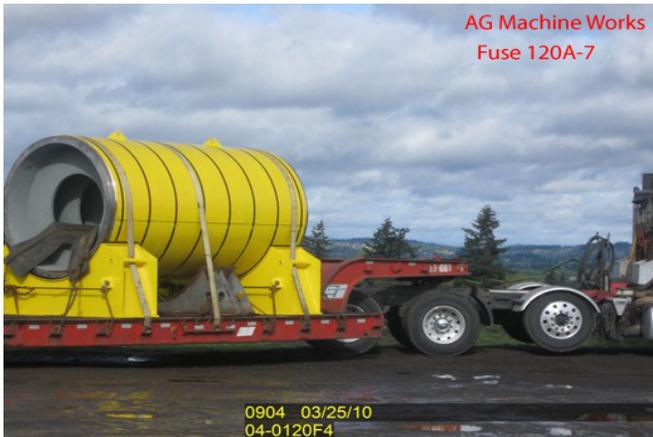
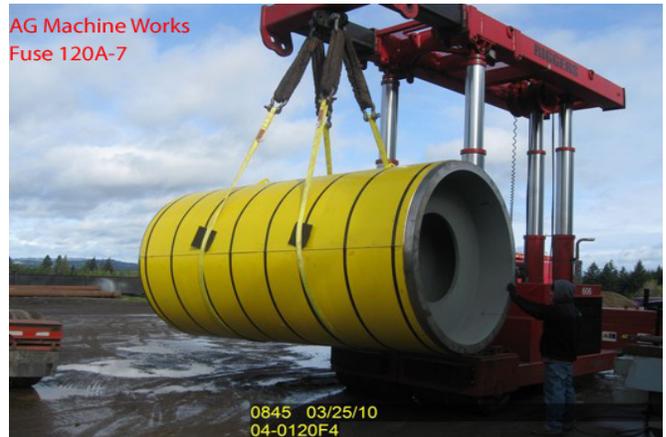
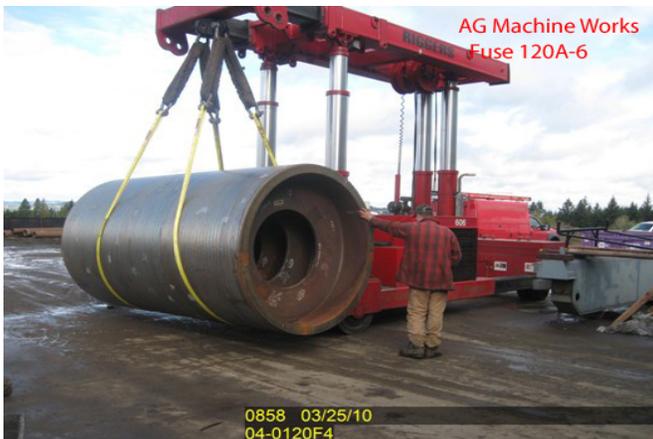
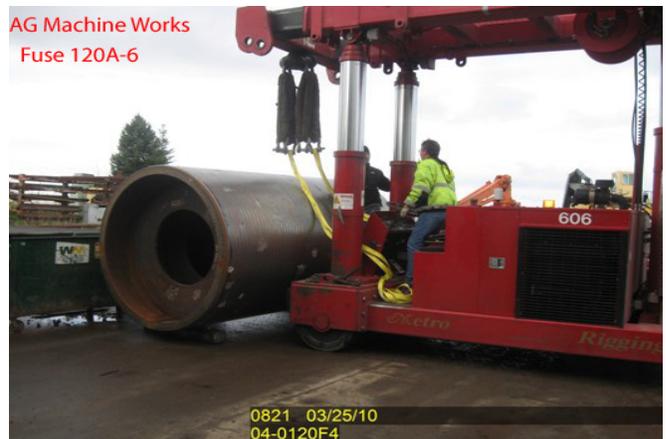
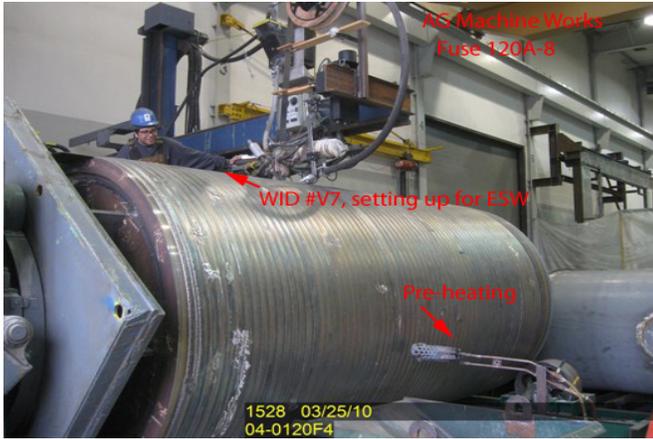
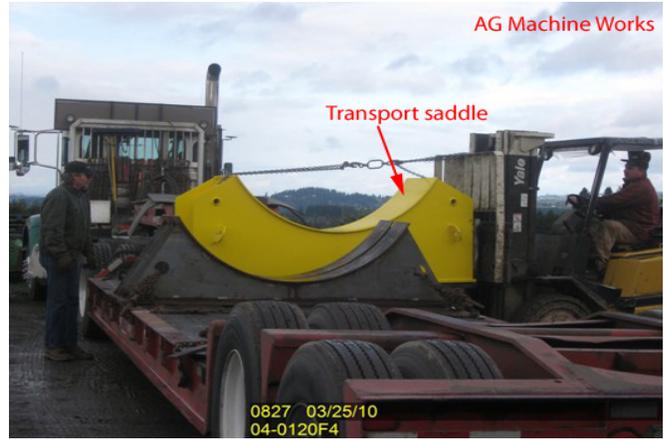
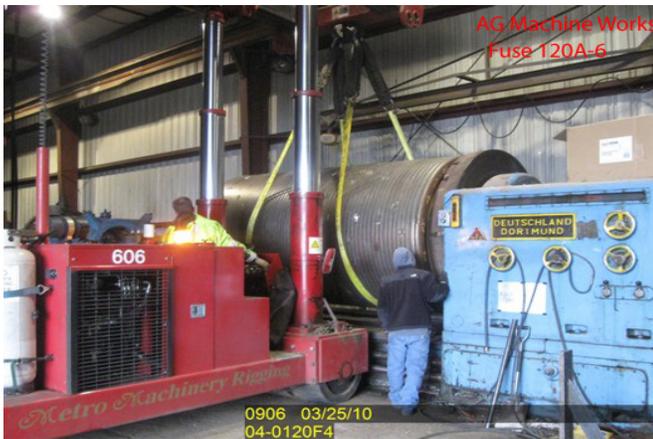
On this date, the QA Inspector arrived at AG Machine shop, to witness OIW switch out Fuse 120A-7 and Fuse 120A-6, for final machining. Upon arrival, the QA Inspector witnessed METRO personell place two slings around the Fuse 120A-6, which had previously arrived at AG on a flatbed trailer. The QA Inspector then witnessed METRO personell attach the slings to a forklift, with a hydraulic lifting boom and hook and placing the Fuse on two 4 x 4 lengths of wood, previously placed on the ground. The QA Inspector then witnessed METRO personell remove these slings from the Fuse 120A-6 and place them around the Fuse 120A-7, currently positioned in a horizontal machining lathe. The QA Inspector noted that a thermal blanket and 2 yellow banded shrouds, had been previously placed on this Fuse, to protect the exterior machined surface, during the rigging activities and transport. The QA Inspector then witnessed Metro Machinery placing this Fuse on a flatbed trailer equipped with two saddles with rubber cushions, which had been placed. The QA Inspector then witnessed Metro personell using two come-a-longs to anchor the Fuse to the trailer and placing rubber cushions on the interior of the Fuse, securing with additional come-a-longs. The QA Inspector noted that the Fuse 120A-7 was being transferred to OIW Vancouver, WA, in preparation for the primer repair areas on the interior portion of the Fuse. The QA Inspector then witnessed Metro picking up the Fuse 120A-6, utilizing the forklift and slings and position into the horizontal lathe. The QA Inspector then witnessed the AG Machinist tighten the lathe chucks, to secure the Fuse in place. The AG Machinist then explained that the first cut pass, for final machining, will start on 3/26/10. See attached pictures below.
