DEPARTMENT OF TRANSPORTATION

Contract #: 04-0120F4Cty: SF/ALA Rte: 80 PM: 13.2/13.9File #: 1x.28**WELDING INSPECTION REPORT****Resident Engineer:** Pursell, Gary**Address:** 333 Burma Road**City:** Oakland, CA 94607**Report No:** WIR-012852**Date Inspected:** 31-Mar-2010**Project Name:** SAS Superstructure**OSM Arrival Time:** 1100**Prime Contractor:** American Bridge/Fluor Enterprises, a JV**OSM Departure Time:** 1930**Contractor:** American Bridge/Fluor Enterprises, a JV**Location:** Job Site

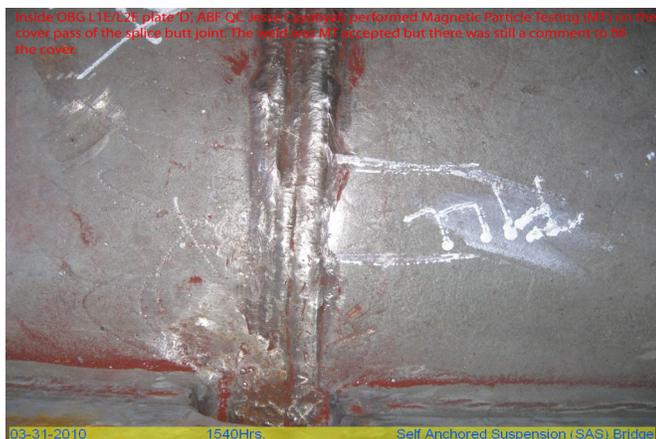
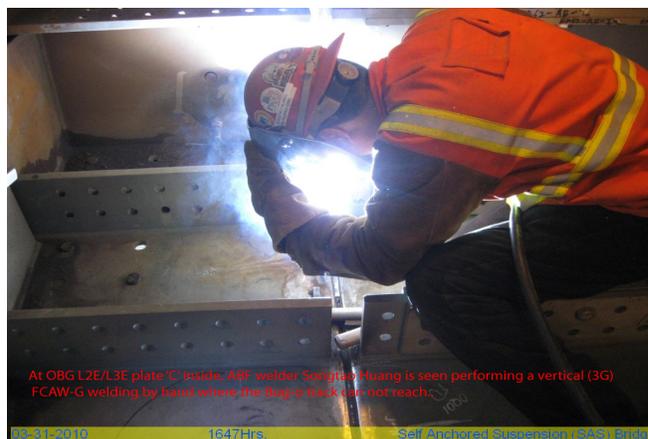
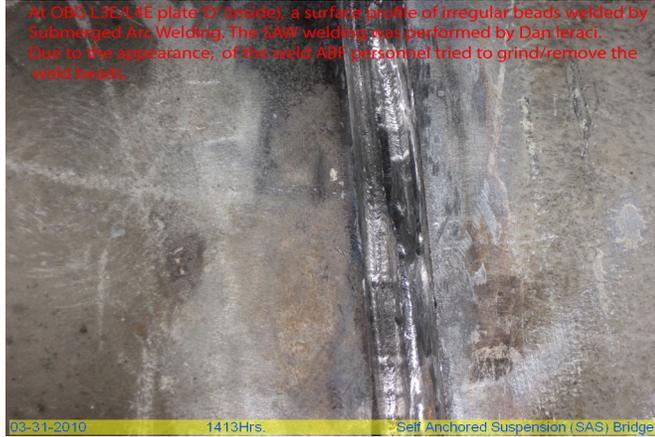
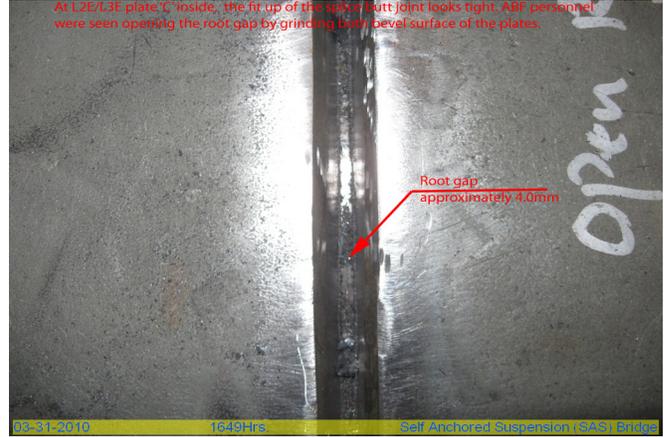
QA randomly observed ABF/JV qualified welders Rory Hogan (ID #3186) and Jeremy Dolman (ID #5042) continue perform CJP groove (splice) back welding fill pass on Orthotropic Box Girder (OBG) L2E/L3E plate 'D1' (0 to 4250mm). The welders were observed welding in the 4G (overhead) position utilizing a dual shield Flux Cored Arc Welding (FCAW-G) with E71T-1M, 1/16" diameter wire electrode and implementing Caltrans approved Welding Procedure Specification (WPS) ABF-WPS-D15-3040A-4. The welder was using a track mounted welder holder assembly that is remotely controlled. The joint being welded has the backing bar gouged using the Esab Plasma Arc machine and was ground smooth. The gouged and ground splice butt joint was also Non Destructive Testing (NDT) tested using the Magnetic Particle Testing (MT) which was performed and accepted by ABF QC Jim Cunningham. The splice joint was preheated to greater than 150 degree Fahrenheit prior welding and the vicinity was properly protected from wind. During welding, ABF Quality Control (QC) Jim Cunningham was noted monitoring the welding parameters of the welder. At the end of the ABF shift, the cover pass of the splice butt joint back weld was completed.

At OBG L3E/L4E plate 'D' inside, ABF personnel were noted removing the slag and grinding the top surface of the pass that Dan Ieraci has deposited using the Submerged Arc Welding (SAW). After grinding, Dan Ieraci was noted Submerged Arc Welding (SAW) welding the groove splice butt joint in flat (1G) position. The welder was utilizing F7A6-EM12K-H8, 3.2mm electrode with corresponding Esab OK Flux 10.62 flux and implementing

At OBG L2E/L3E plate 'C' inside, QA observed the middle section of the plate was completely welded and the welders have moved to the top section of plate 'C'. Prior moving, ABF personnel were seen removing the stiffener connection plates to have access for the FCAW-G welding. After the removal of the stiffener plates, the ABF personnel were seen grinding the bevel surface of both plates to have wider root gap. The root gap measured in this location was around 4.0mm.

At OBG L1E/L2E plate D inside, QA observed ABF QC Jesse Cayabyab perform Magnetic Particle Testing (MT) on the cover pass of the splice butt joint. The ABF QC was using a Magnaflux AC/DC electromagnetic yoke with serial number 517750 and red magnetic powder as detecting media. At the end of MT, QC has MT accepted all the plates in between stiffener plates marked D1 to D19 except D18 wherein QC has marked "grind" on three locations due to the presence of slag. QC has also marked "fill" on one of the plates marked D14 due to underfill on the toe of the weld but this was QC MT accepted.
