DEPARTMENT OF TRANSPORTATION

Contract #: 04-0120F4Cty: SF/ALA Rte: 80 PM: 13.2/13.9File #: 1.28**WELDING INSPECTION REPORT****Resident Engineer:** Pursell, Gary**Address:** 333 Burma Road**City:** Oakland, CA 94607**Report No:** WIR-012857**Date Inspected:** 01-Apr-2010**Project Name:** SAS Superstructure**OSM Arrival Time:** 1100**Prime Contractor:** American Bridge/Fluor Enterprises, a JV**OSM Departure Time:** 1930**Contractor:** American Bridge/Fluor Enterprises, a JV**Location:** Job Site**CWI Name:** See Below**CWI Present:** Yes No**Inspected CWI report:** Yes No N/A**Rod Oven in Use:** Yes No N/A**Electrode to specification:** Yes No N/A**Weld Procedures Followed:** Yes No N/A**Qualified Welders:** Yes No N/A**Verified Joint Fit-up:** Yes No N/A**Approved Drawings:** Yes No N/A**Approved WPS:** Yes No N/A**Delayed / Cancelled:** Yes No N/A**Bridge No:** 34-0006**Component:** Orthotropic Box Girders**Summary of Items Observed:**

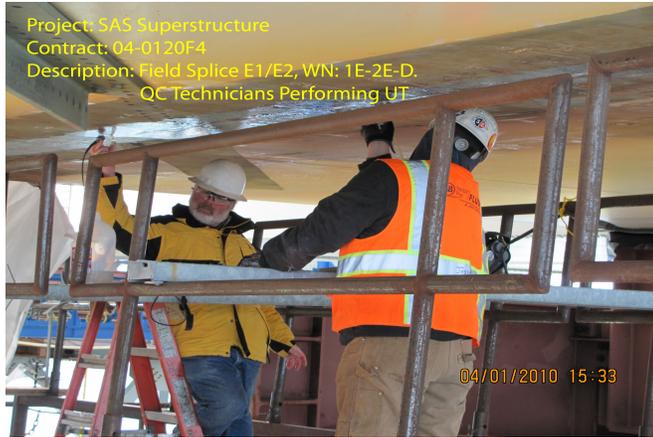
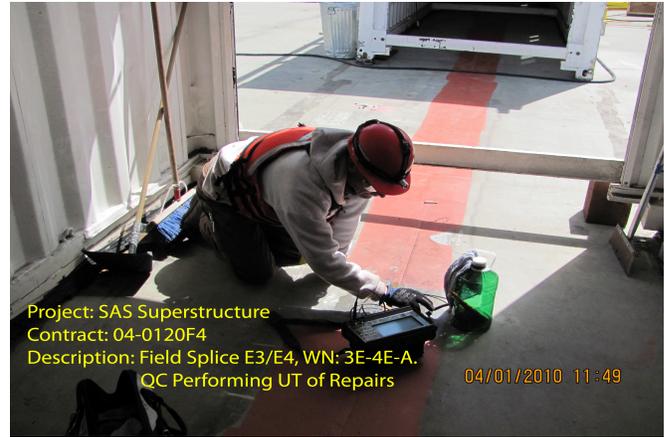
The digital photographs, below, illustrates the work observed during this scheduled shift.
