Contract #: 04-0120F4Cty: SF/ALA Rte: 80 PM: 13.2/13.9File #: 1.28**WELDING INSPECTION REPORT****Resident Engineer:** Pursell, Gary**Address:** 333 Burma Road**City:** Oakland, CA 94607**Report No:** WIR-012862**Date Inspected:** 02-Apr-2010**Project Name:** SAS Superstructure**OSM Arrival Time:** 630**Prime Contractor:** American Bridge/Fluor Enterprises, a JV**OSM Departure Time:** 1500**Contractor:** American Bridge/Fluor Enterprises, a JV**Location:** Job Site

Bridge No: 34-0006**Summary of Items Observed:**

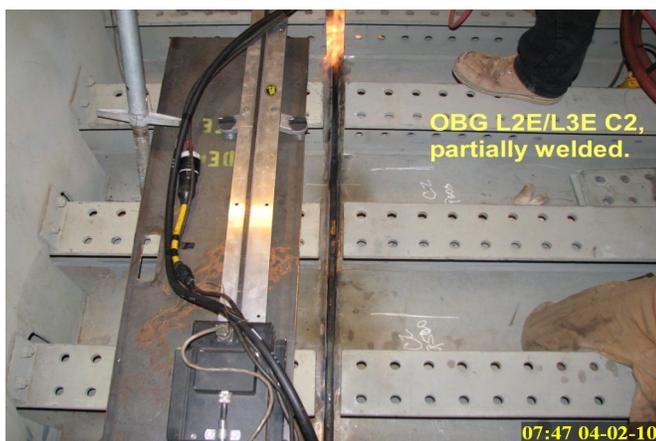
1) The QAI observed ABF personnel welding plate C at L2E/L3E field splice. The QAI noted that this complete joint penetration (CJP) weld is being made in segment C2 from 7500mm to 10000mm. See the attached photo. The QAI noted that the Quality Control (QC) Inspector Bernie Docena is monitoring this welding. The QAI observed ABF workers Mitch Sittinger, ID 0315, and Chun Fai Tsui, ID 3426, making the welds with gas shielded flux cored arc welding (FCAW-G). The QAI was informed that welding procedure specification (WPS) ABF-WPS-D15-3040A-1 is being used for this welding. The QAI randomly measured the welding parameters and noted that they appeared to be conforming to the WPS requirements. The QAI randomly measured the preheat and interpass temperature and noted that they did not appear to be conforming to the WPS and contract requirements. The QAI noted that twice during this shift, the temperature was measured to be below the minimum of 200°F. The lowest observed temperature was below 150°F in the 9000mm to 10000mm section of the weld segment. The QAI relayed these observations to the QC Inspector. The QAI also wrote a non-conforming incident report to document the observations. See the appropriate TL-15 for additional information. The QAI noted that upon identification of weld / base metal will low preheat / interpass temperature, ABF personnel used propane torches to restore the required temperature and welding operations continued.

As noted above, the QAI had conversations with the QC Inspector Bernie Docena regarding required minimum preheat temperature. The QC Inspector confirmed that based on the WPS and weld thickness, the temperature was not supposed to be below 200°F. The QAI had other general conversations with the QC Inspectors regarding the observed work in progress. The QAI relayed the observations of OBG splice welding to the QAI Danny Reyes. The QAI also relayed the non-conforming incident report to the QAI Lead Bill Levell. The QAI also generated a shift turn-over report with this information. There were no other notable observations or conversations during this shift.

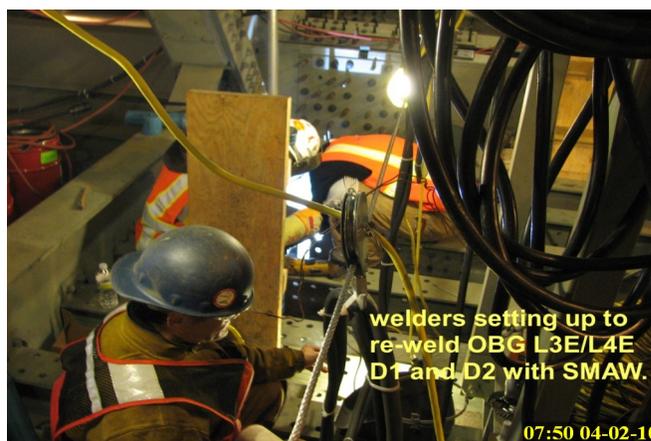
2) The QAI observed ABF personnel using grinders to remove the welds at L3E/L4E bottom plate D field splice. The QAI was informed that previously made welds were being removed because slag was present. The QAI observed that after the welds were ground down, shielded metal arc welding (SMAW) with 1/8" E7018 electrodes were used to make the root pass of weld segments D1 and D2. See the attached photo. The QAI noted that ABF workers Jordan Hazelaar, ID 2135, Song Tao Huang, ID 3794, and James Zhen, ID 6001, were performing the welding at this location. The QAI noted that the QC Inspector Tom Pasqualone is monitoring this welding. The QAI was informed that after an acceptable root pass is made with SMAW, submerged arc welding (SAW) will be used to finish the welding. The QAI Danny Reyes arrived and assumed the QA duties at this location.
