DEPARTMENT OF TRANSPORTATION

Contract #: 04-0120F4Cty: SF/ALA Rte: 80 PM: 13.2/13.9File #: 69.28**WELDING INSPECTION REPORT****Resident Engineer:** Pursell, Gary**Address:** 333 Burma Road**City:** Oakland, CA 94607**Report No:** WIR-012887**Date Inspected:** 05-Apr-2010**Project Name:** SAS Superstructure**OSM Arrival Time:** 700**Prime Contractor:** American Bridge/Fluor Enterprises, a JV**OSM Departure Time:** 1900**Contractor:** Zhenhua Port Machinery Company, Ltd (ZPMC), Changxing Island **Location:** Shanghai, China

OBG 7DW, 7DE, 7EE

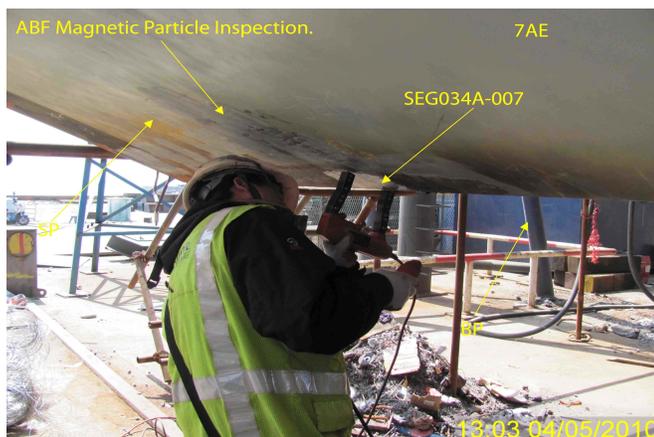
This QA Inspector Witnessed ABF personal performing Magnetic particle Testing (MT) on weld between side panel and bottom panel (bike path side) of OBG segment 7AE. Weld are identified as

SEG034A-007 (7AE@6CE- SP to BP, B.P side)

No relevant indication was observed.
