Contract #: 04-0120F4Cty: SF/ALA Rte: 80 PM: 13.2/13.9File #: 13.28**WELDING INSPECTION REPORT****Resident Engineer:** Pursell, Gary**Address:** 333 Burma Road**City:** Oakland, CA 94607**Report No:** WIR-012944**Date Inspected:** 01-Apr-2010**Project Name:** SAS Superstructure**OSM Arrival Time:** 1000**Prime Contractor:** American Bridge/Fluor Enterprises, a JV**OSM Departure Time:** 1830**Contractor:** Oregon Iron Works Clackamas, Or.**Location:** Clackamas, OR**CWI Name:** M. Gregson, J. Salazar**CWI Present:** Yes No**Inspected CWI report:** Yes No N/A**Rod Oven in Use:** Yes No N/A**Electrode to specification:** Yes No N/A**Weld Procedures Followed:** Yes No N/A**Qualified Welders:** Yes No N/A**Verified Joint Fit-up:** Yes No N/A**Approved Drawings:** Yes No N/A**Approved WPS:** Yes No N/A**Delayed / Cancelled:** Yes No N/A**Bridge No:** 34-0006**Component:** Hinge K Pipe Beams**Summary of Items Observed:**

Hinge-K Pipe Beam Assembly 102A-2:

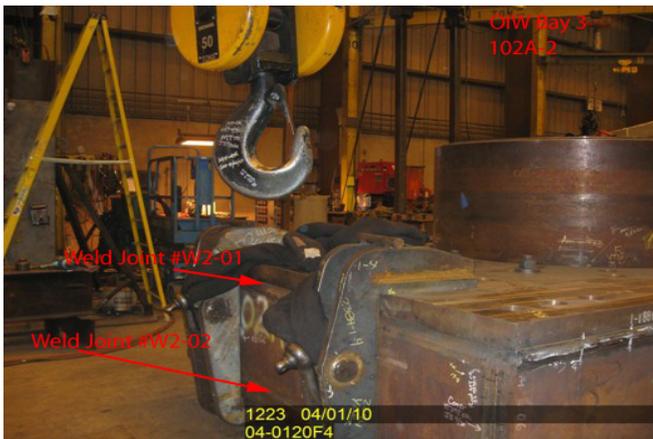
The QA Inspector witnessed WID #B62 (Marcus Belgarde) and Production Lead Troy Smith attaching 2 slings to previously placed clamps, on the assembly. Lead Troy Smith explained that the slings are being placed in preparation for flipping the assembly for the Submerged Arc Welding on weld joints # W2-01 and W2-02. Lead Troy Smith explained that the slings will be attached to the overhead bay crane and then the assembly will be lifted and placed on the shop floor. Lead Troy Smith explained that the clamps will be re-attached to the opposite side of the assembly and then will be lifted in the upright position and then placed to access the weld joints. The QA Inspector noted that the weld joints are the Partial Penetration, a109 Cap Plate/a110 Base Plate to b106 stiffener. Lead Troy Smith explained that once the Assembly is in position, the Cooperheat would be placed to begin pre-heating in preparation for the SAW. See attached picture below.

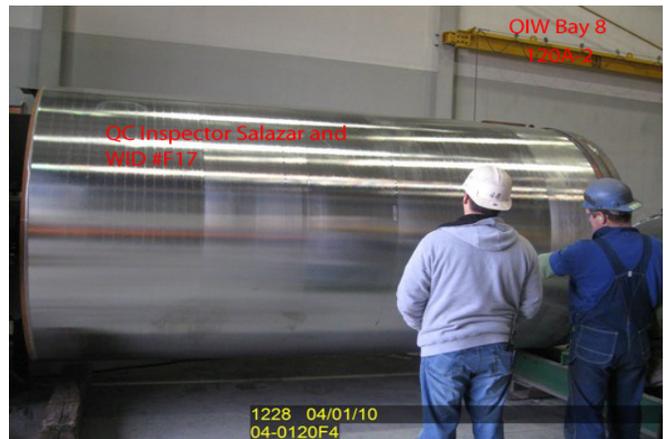
Hinge-K Pipe Beam Assembly 120A-8:

The QA Inspector was informed by OIW QC Inspector Jose Salazar that WID #F17 was currently setting up in preparation for the Electroslag Welding (ESW) on the Fuse. QC Inspector Salazar explained that the Fuse had previously placed on 2 sets of rollers and WID #F17 was currently setting up the Submerged Arc Welding machine and a stationary torch. The QA Inspector noted that OIW is setting up to apply an additional layer of

316L overlay material, to achieve the minimum outside diameter requirements, after the Fuse is machined. See attached picture below.
