DEPARTMENT OF TRANSPORTATION

Quality Assurance and Source Inspection

Contract #: 04-0120F4Cty: SF/ALA Rte: 80 PM: 13.2/13.9File #: 69.28**WELDING INSPECTION REPORT****Resident Engineer:** Pursell, Gary**Address:** 333 Burma Road**City:** Oakland, CA 94607**Report No:** WIR-012961**Date Inspected:** 08-Apr-2010**Project Name:** SAS Superstructure**OSM Arrival Time:** 700**Prime Contractor:** American Bridge/Fluor Enterprises, a JV**OSM Departure Time:** 1900**Contractor:** Zhenhua Port Machinery Company, Ltd (ZPMC), Changxing Island **Location:** Shanghai, China**CWI Name:** Li Yang**CWI Present:** Yes No**Inspected CWI report:** Yes No N/A**Rod Oven in Use:** Yes No N/A**Electrode to specification:** Yes No N/A**Weld Procedures Followed:** Yes No N/A**Qualified Welders:** Yes No N/A**Verified Joint Fit-up:** Yes No N/A**Approved Drawings:** Yes No N/A**Approved WPS:** Yes No N/A**Delayed / Cancelled:** Yes No N/A**Bridge No:** 34-0006**Component:** OBG**Summary of Items Observed:**

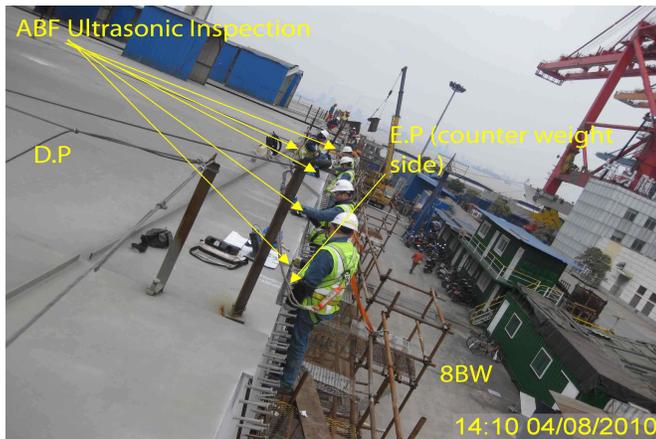
Unless otherwise noted, all work observed on this dated appeared to generally comply with applicable contract documents.
