**DEPARTMENT OF TRANSPORTATION**

Contract #: 04-0120F4Cty: SF/ALA Rte: 80 PM: 13.2/13.9File #: 1.28**WELDING INSPECTION REPORT****Resident Engineer:** Pursell, Gary**Address:** 333 Burma Road**City:** Oakland, CA 94607**Report No:** WIR-012969**Date Inspected:** 05-Apr-2010**Project Name:** SAS Superstructure**OSM Arrival Time:** 630**Prime Contractor:** American Bridge/Fluor Enterprises, a JV**OSM Departure Time:** 1500**Contractor:** American Bridge/Fluor Enterprises, a JV**Location:** Job Site

The Quality Assurance (QA) Inspector, Rick Bettencourt was on site at the job site between the times noted above. The QA Inspector was on site to randomly observe the in process welding and inspection of the weld joints identified as 1W/2W-A1/A5, 1E/2E-E1/E2, 2E/3E-C1/C2 and the following observations were made:

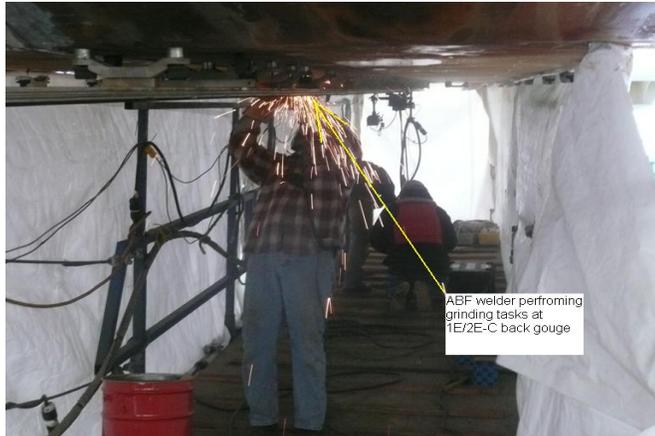
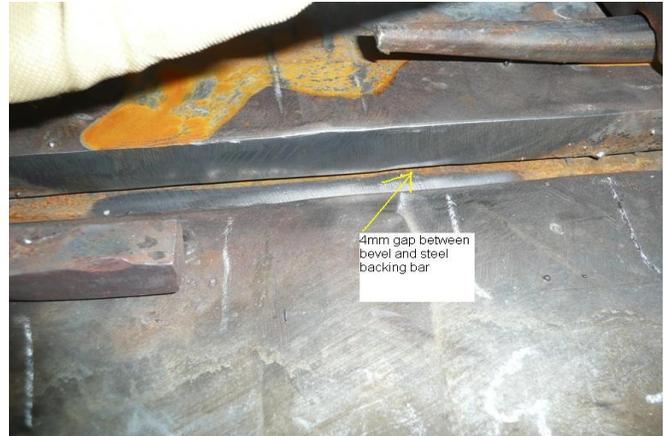
Upon the arrival of the QA Inspector it was observed no welding was being performed at the above identified location. The QA Inspector performed a random visual inspection of the fit up A1-A5. The QA Inspector noted the induction heating blankets were in place and turned on, the QA Inspectors access was limited. The QA Inspector randomly observed the American Bridge/Fluor (ABF) welders Jordan Hazelaar and Kenneth Chappell begin setting up to perform shielded metal arc welding (SMAW), in an attempt to join the members by welding. The QA Inspector noted the steel backing bar was previously tack welded full length from one side of the steel backing bar only. The QA Inspector noted the ABF welders were preparing and preheating to tack weld the opposite side of the steel backing and join the two members by welding. The QA Inspector performed random visual and dimensional testing of the fit up prior to and during the SMAW tack welding. The QA Inspector noted several areas of planar misalignment that exceeds that allowed by AWS D1.5-02 section 3.3.3 In addition the QA Inspector noted several areas where the gap at the steel backing and the bevel exceed 2mm which exceeded the maximum allowable by AWS D1.5-02 section 3.3.1.1. The following locations of the above identified issues are as described below:

The unacceptable planar misalignment was located at the following locations:

A2-y=2275mm-3575mm 3-5mm misalignment (1300mm in length)

A2-y=5200mm-5500mm 3-4mm misalignment (300mm in length)

A3-y=0mm-500mm 3-4mm misalignment (500mm in length)

A4-y=4350mm-5350 3-6mm misalignment (1000mm in length)

A5-y=0mm-40mm 3-3.5mm misalignment (40mm in length)

A5-y=2260mm-2680mm 3mm misalignment (410mm in length)

The gaps between the faying surface and the landing which exceed 2mm identified below:

A2-y=2475mm-3735mm, gap at steel backing 3-3.5mm (length 1260mm)

A2/A3-y=A2-5250mm-A3-600mm, gap at steel backing 3mm-3.5mm (length 750mm)

A4-y=1080mm-1690mm, gap at steel backing 3mm (length 610mm)

A4-y=4350mm-5350, gap at steel backing 3-5mm (approximately 1000mm)

The QA Inspector pointed out the SE Quality Control Manager (QCM) Leonard Cross the fit box in the QC charts on the top deck plate had not been checked off or accepted. The QA Inspector went on to point out that the weld joint was being joined by welding at that time and significant amounts of planar misalignment still existed at the time of welding. Mr. Cross informed the QA Inspector he was aware of the misalignment as well as his QC Inspectors performing the dimensional inspections. Mr. Cross went on to inform the QA Inspector, the chart is not checked off for the fit up is due to the current condition of the fit members. Mr. Cross acknowledged the unacceptable fit up and planar misalignment of the two top deck plates, but informed the QA Inspector ABF is stating no additional fit up could be performed due to the rigidity of the steel and the as built dimensions. The SE QCM informed the QA Inspector; SE QC Inspectors are recording and mapping all areas of planar misalignment and where the gap at the steel backing exceeds 2mm.
