DEPARTMENT OF TRANSPORTATION

Contract #: 04-0120F4Cty: SF/ALA Rte: 80 PM: 13.2/13.9File #: 1x.28**WELDING INSPECTION REPORT****Resident Engineer:** Pursell, Gary**Address:** 333 Burma Road**City:** Oakland, CA 94607**Report No:** WIR-012971**Date Inspected:** 08-Apr-2010**Project Name:** SAS Superstructure**OSM Arrival Time:** 1100**Prime Contractor:** American Bridge/Fluor Enterprises, a JV**OSM Departure Time:** 1930**Contractor:** American Bridge/Fluor Enterprises, a JV**Location:** Job Site

WELDING INSPECTION REPORT

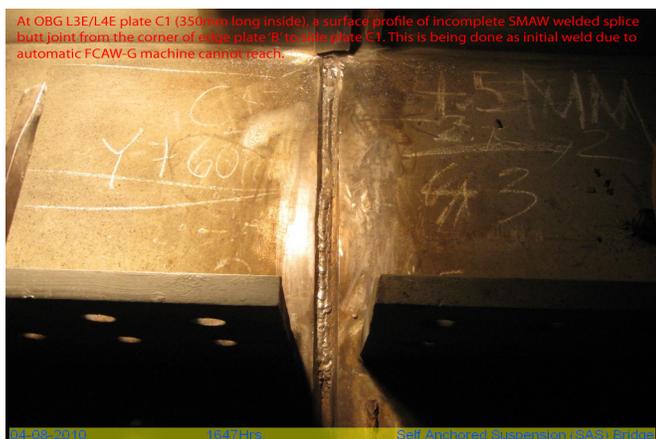
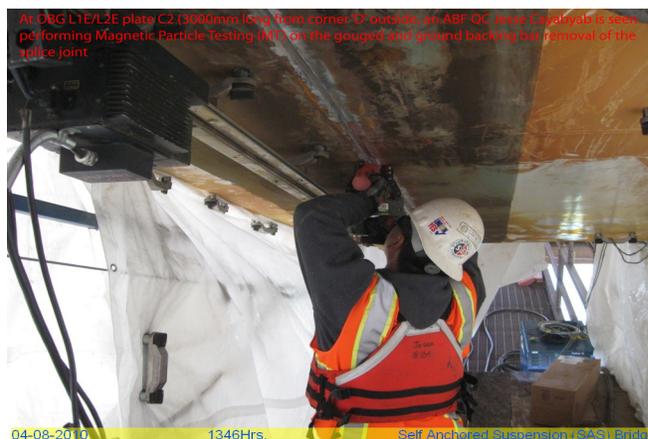
In another OBG location, OBG L1E/L2E plate 'C', QA observed ABF QC personnel Jesus Cayabyab perform Magnetic Particle Testing (MT) on the gouged and ground splice joint that was left previously due to backing bar still not gouged. The length of the area was 3000mm from the corner of 'D' plate to the top of 'C'. The ABF QC was using a Magnaflux AC/DC electromagnetic yoke with serial number 517750 and red magnetic powder as detecting media. QA noted that as QC finds indication, the welder immediately ground the indication and at the end of the MT, QC informed QA that the MT of the gouged and ground backing bar removal was acceptable.
