**DEPARTMENT OF TRANSPORTATION**

Contract #: 04-0120F4Cty: SF/ALA Rte: 80 PM: 13.2/13.9File #: 1.28**WELDING INSPECTION REPORT****Resident Engineer:** Pursell, Gary**Address:** 333 Burma Road**City:** Oakland, CA 94607**Report No:** WIR-012991**Date Inspected:** 12-Apr-2010**Project Name:** SAS Superstructure**OSM Arrival Time:** 630**Prime Contractor:** American Bridge/Fluor Enterprises, a JV**OSM Departure Time:** 1500**Contractor:** American Bridge/Fluor Enterprises, a JV**Location:** Job Site

# WELDING INSPECTION REPORT

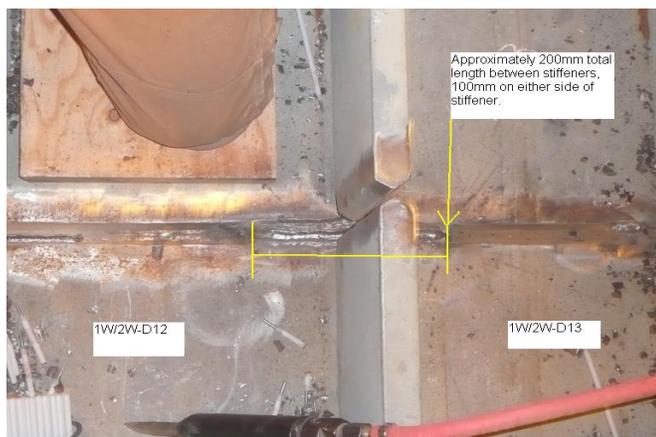
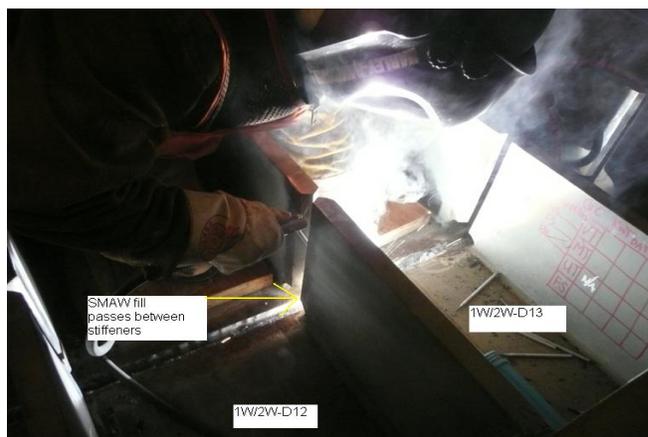
The QA Inspector randomly observed the American Bridge/Fluor (ABF) welder identified as Chun Fai Tsui was performing SMAW between the locations identified above. It was noted the same process of welding approximately 200mm under the stiffeners and 100mm on either side is how the production welding was being sequenced. The QA Inspector noted the SMAW root pass had been previously completed to the QA Inspectors arrival. The QA Inspector randomly observed the ABF welder performing the SMAW fill/cover passes for the duration of the QA Inspectors shift. The QA Inspector noted the ABF welder was utilizing 1/8" E7018 H4R low hydrogen electrodes with 147 Amps. The QA Inspector noted the CJP groove as well as surrounding base material was being maintained above 150°F. The QA Inspector noted the SMAW parameters appeared to be in general compliance with ABF-WPS-D1.5-1040-C. The QA Inspector randomly observed the ABF welder complete the area identified above. After the area was completed the QA Inspector randomly observed the ABF welder move and begin performing SMAW fill passes in D7. It was observed the ABF welder was performing the SMAW fill passes in D7 for the remainder of the QA Inspectors shift.

The QA Inspector randomly observed the ABF welder identified as James Zhen was performing SMAW between the locations identified above. It was noted the same process of welding approximately 200mm under the stiffeners and 100mm on either side is how the production welding was being sequenced. The QA Inspector noted the SMAW root pass had been previously completed to the QA Inspectors arrival. The QA Inspector randomly observed the ABF welder performing the SMAW fill/cover passes for the duration of the QA Inspectors shift. The QA Inspector noted the ABF welder was utilizing 1/8" E7018 H4R low hydrogen electrodes with 145 Amps. The QA Inspector noted the CJP groove as well as surrounding base material was being maintained above 150°F. The QA Inspector noted the SMAW parameters appeared to be in general compliance with ABF-WPS-D1.5-1040-C. The QA Inspector randomly observed the ABF welder complete the area identified above. After the area was completed the QA Inspector randomly observed the ABF welder move and begin performing the same SMAW fill passes between D11/D12. It was observed the ABF welder was performing the SMAW fill passes in D11/D12 for the remainder of the QA Inspectors shift.
